- ▶ Final Report
- ▶ ▶ Rail Safety Investigation
- ▶ ▶ ▶ QT2459

Fatal Collision between the Cairns Tilt Train and B-Double Truck  
Rungoo Level Crossing, Queensland  
27 November 2008

ISBN 978-0-734525-59-8

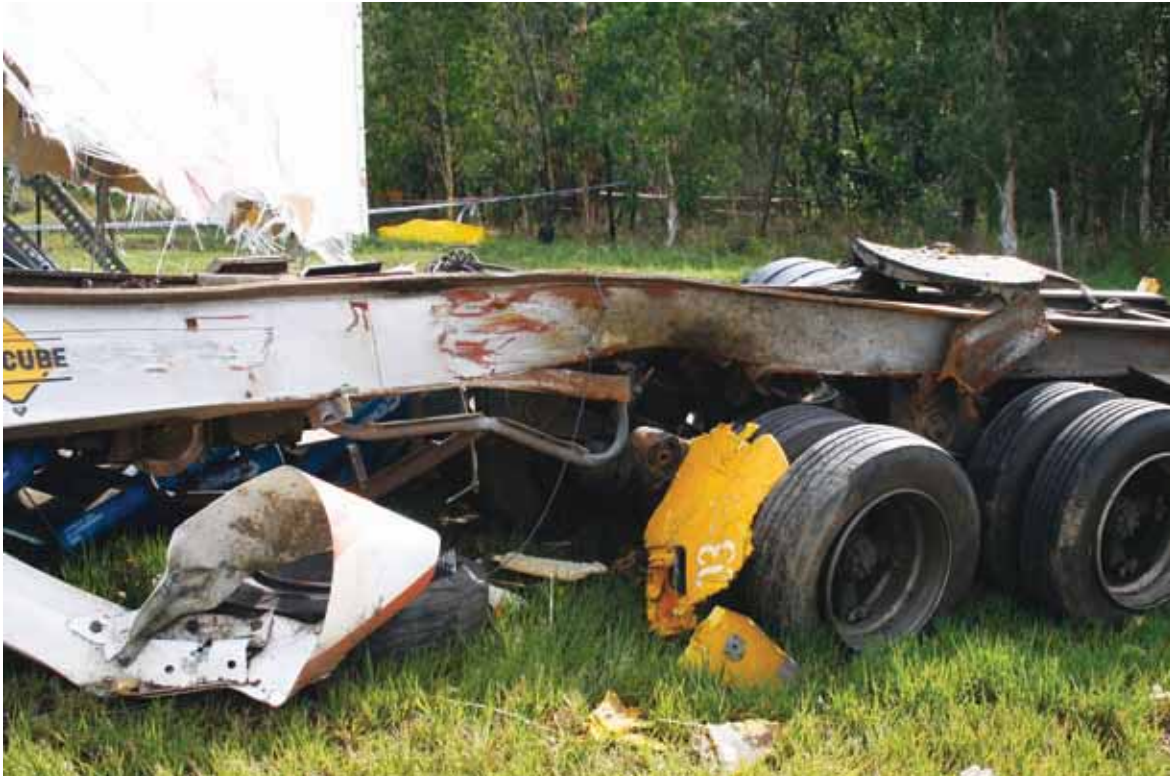
Figure 6: Point of impact B-double truck

The leading end of the lead power car of train VCQ5 impacted the A trailer of the B-double truck at a point about eight metres from the front bull-bar of the prime-mover. Figure 6 shows a schematic diagram of the point of impact. The photo in figure 6 shows where the front of the train 'slid' along the trailer before 'catching' on the bogie between the A and B trailers. The initial point of impact is just out of range to the left of the photo.

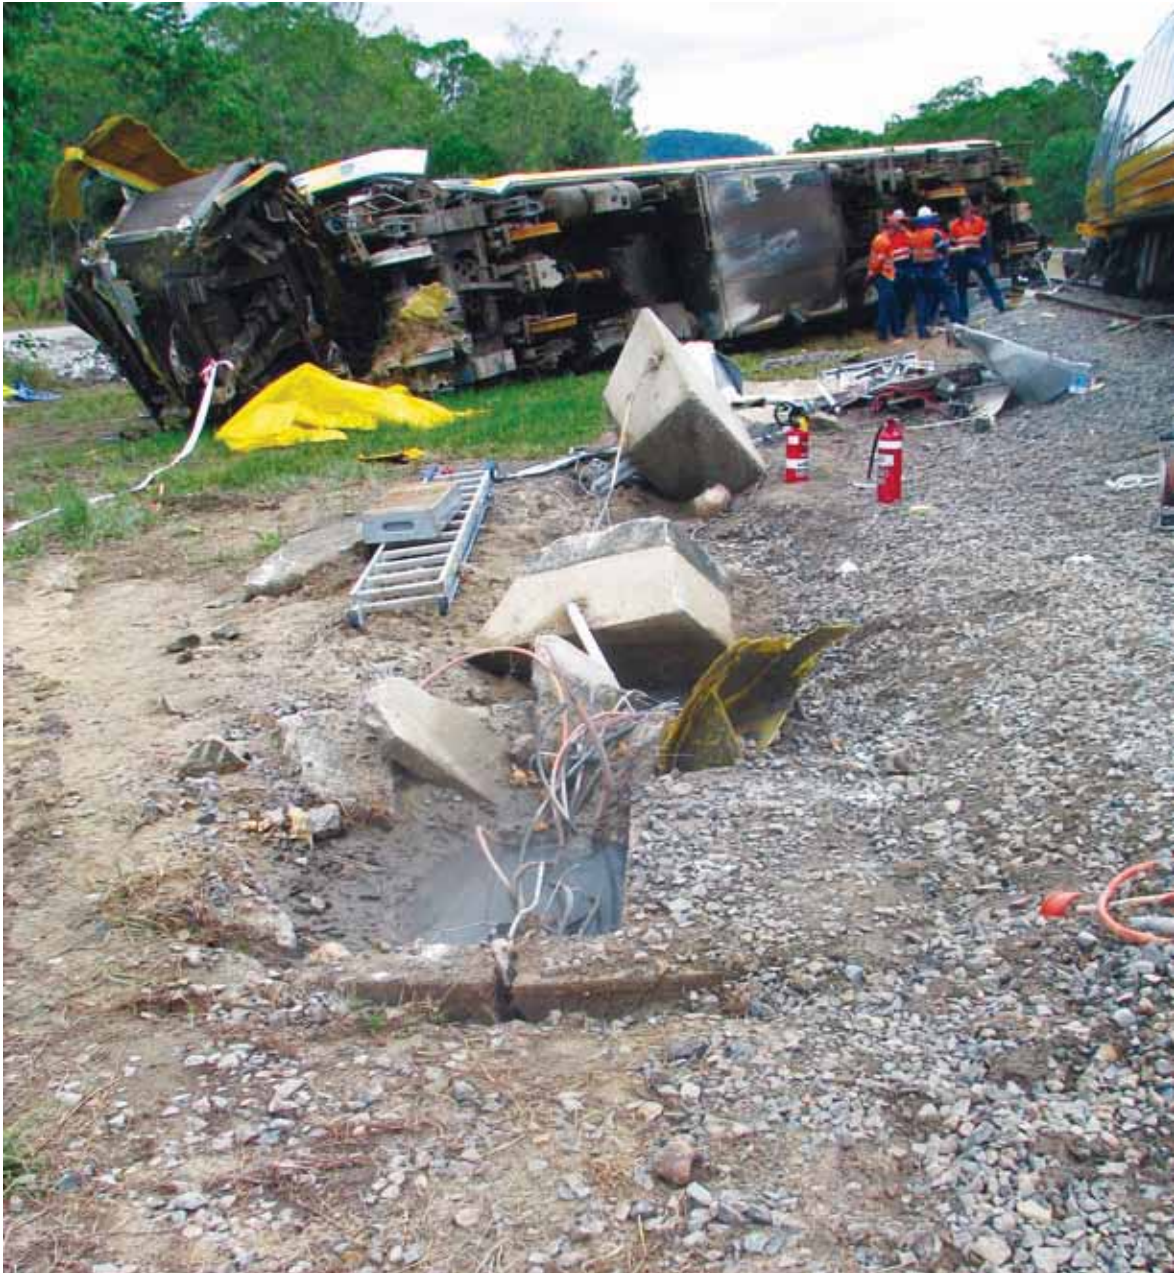
**Figure 7:** *Final position of power car showing impact with concrete block*

During this sequence the right-hand side of the power car impacted the concrete block supporting the wayside level crossing control equipment cabinet. The power car was still upright at this stage. The power car then overturned onto its right-hand side a few metres from coming to rest, sliding backwards in the process. When it came to rest, the power car was facing in a south-south-easterly direction.

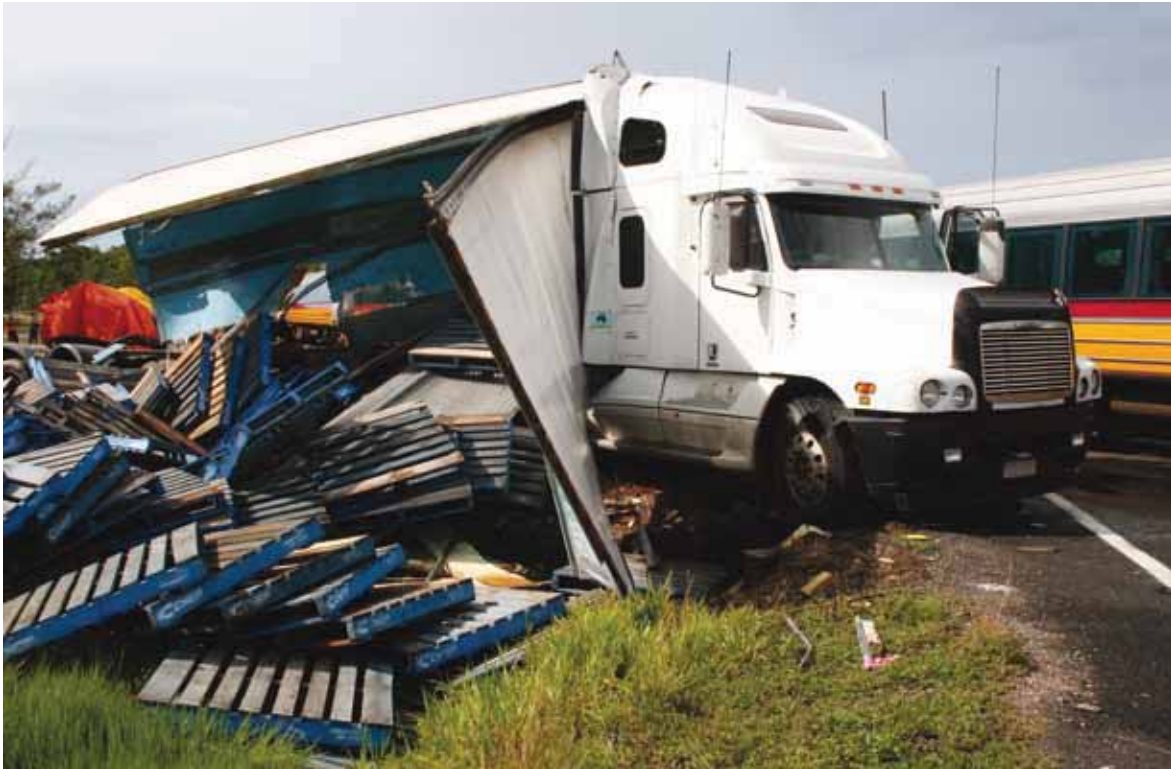
**Figure 8:** *Prime-mover and ruptured A trailer*

The prime-mover of the B-double truck rotated anti-clockwise about 70 degrees and came to a rest almost parallel with the rail line. The leading wheels of the prime-mover came to rest on the edge of the bitumen in the north-bound lane of the Bruce Highway.

The A trailer, which was still coupled to the prime-mover, had ruptured and the load of empty pallets were scattered over the immediate area.

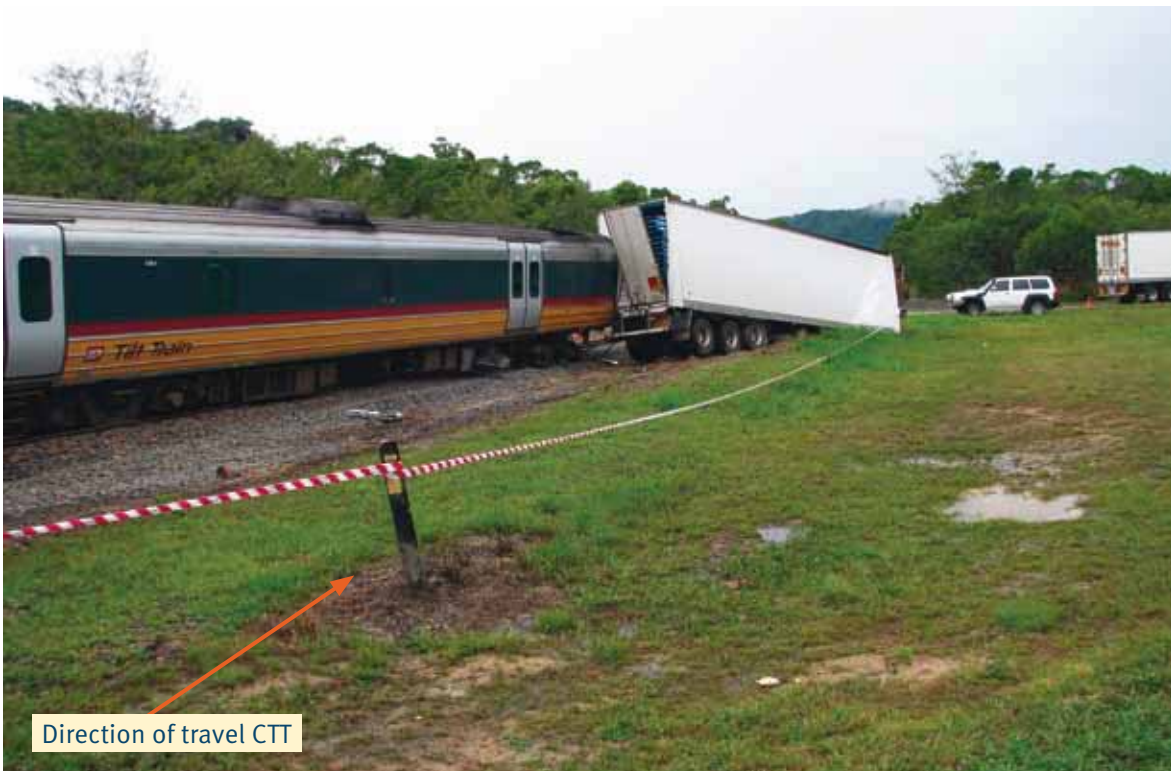
**Figure 9:** *B trailer wedged in the front of the baggage car*

The rear end of the B trailer had become wedged in the leading end of the luggage carriage and was pushed forward about 55 m by the momentum of the train. The B trailer came to a rest facing in the same direction as the train ('north-westerly').

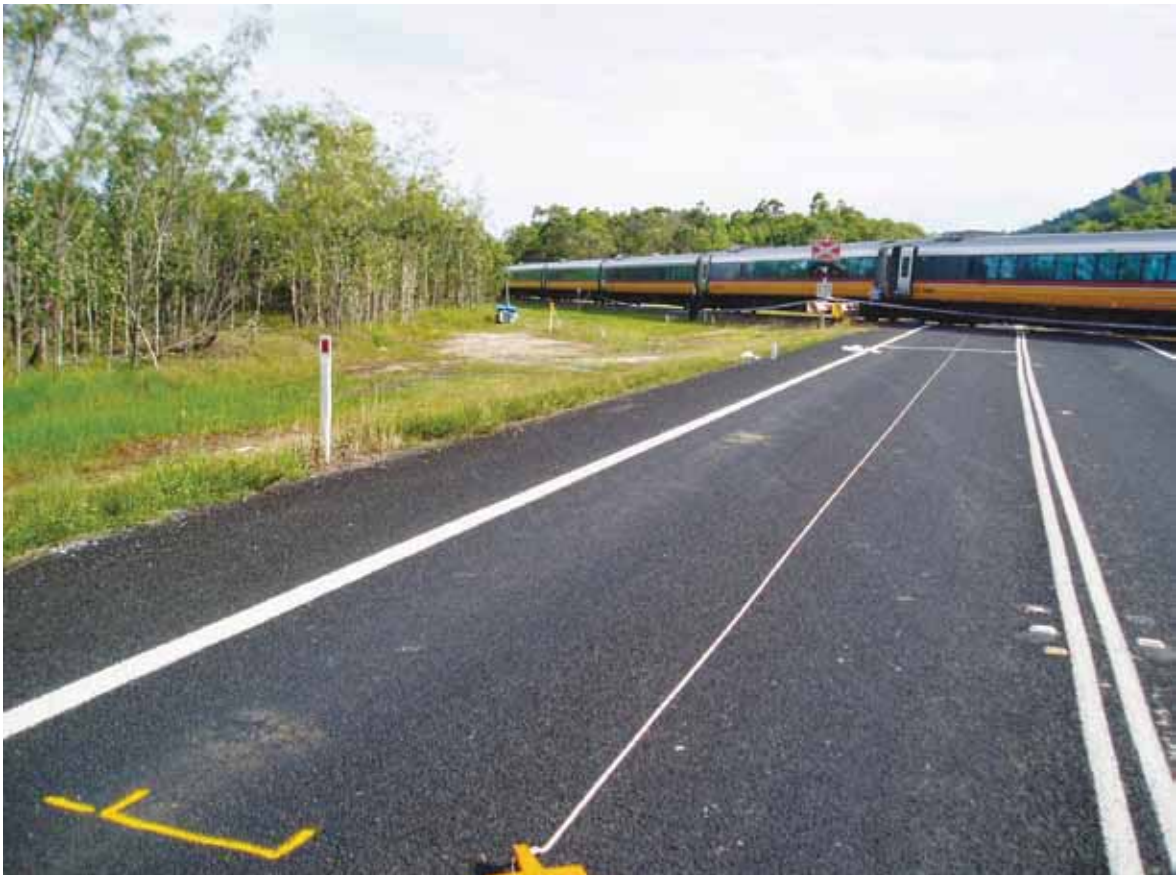
**Figure 10:** *Skid marks 46.9 m long*

Of note is that 46.9 m of skid marks, close to the centre of the southbound lane, were found on the northern side of the level crossing. These marks extended to within several metres of the level crossing. Although faint, about halfway along these marks there appeared to be overlapping dual tyre markings, indicating that the actual braking distance was about 21 m, 46.9 m minus the length of the B-double truck (26 m).

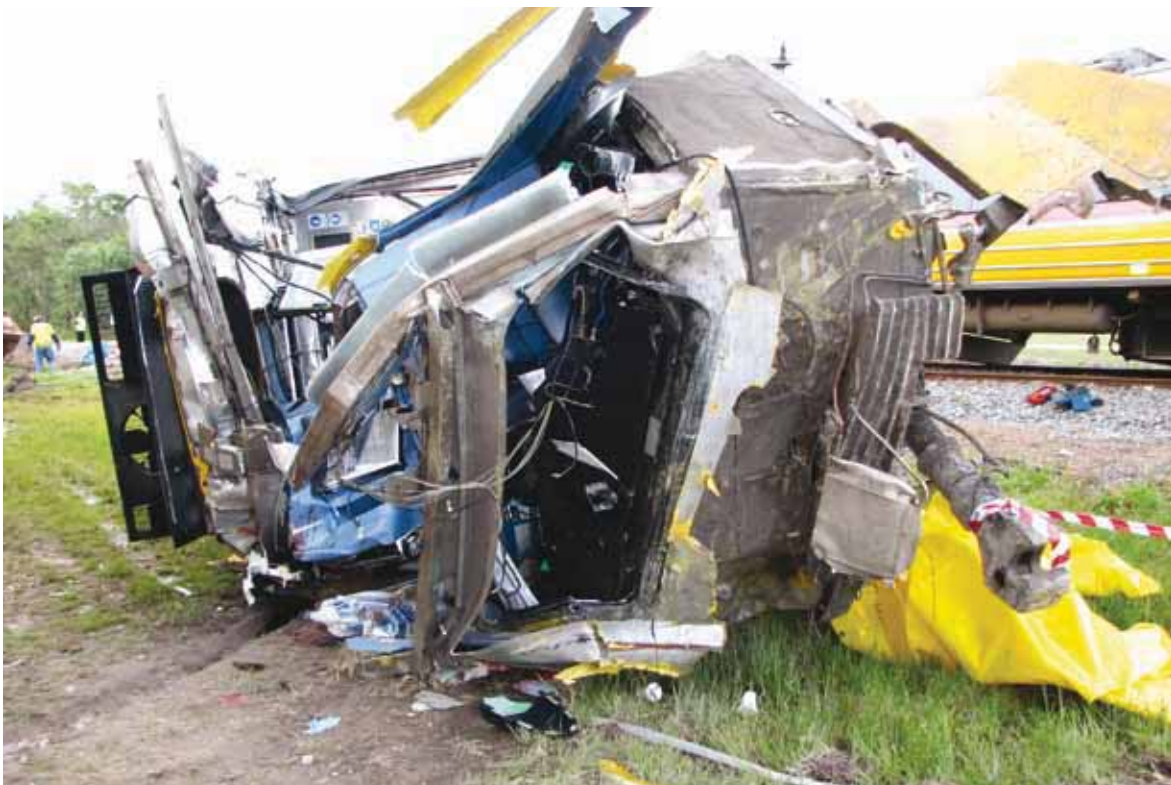
Figure 12: *Driver's cab and vestibule*

The lead power car (DTD 5403) incurred severe structural damage. This damage was particularly severe in the vicinity of the driver's vestibule and cabin. A detailed description of the damage and analysis of the crashworthiness of lead power car (DTD 5403) is provided at sections 2.4 and 2.5.

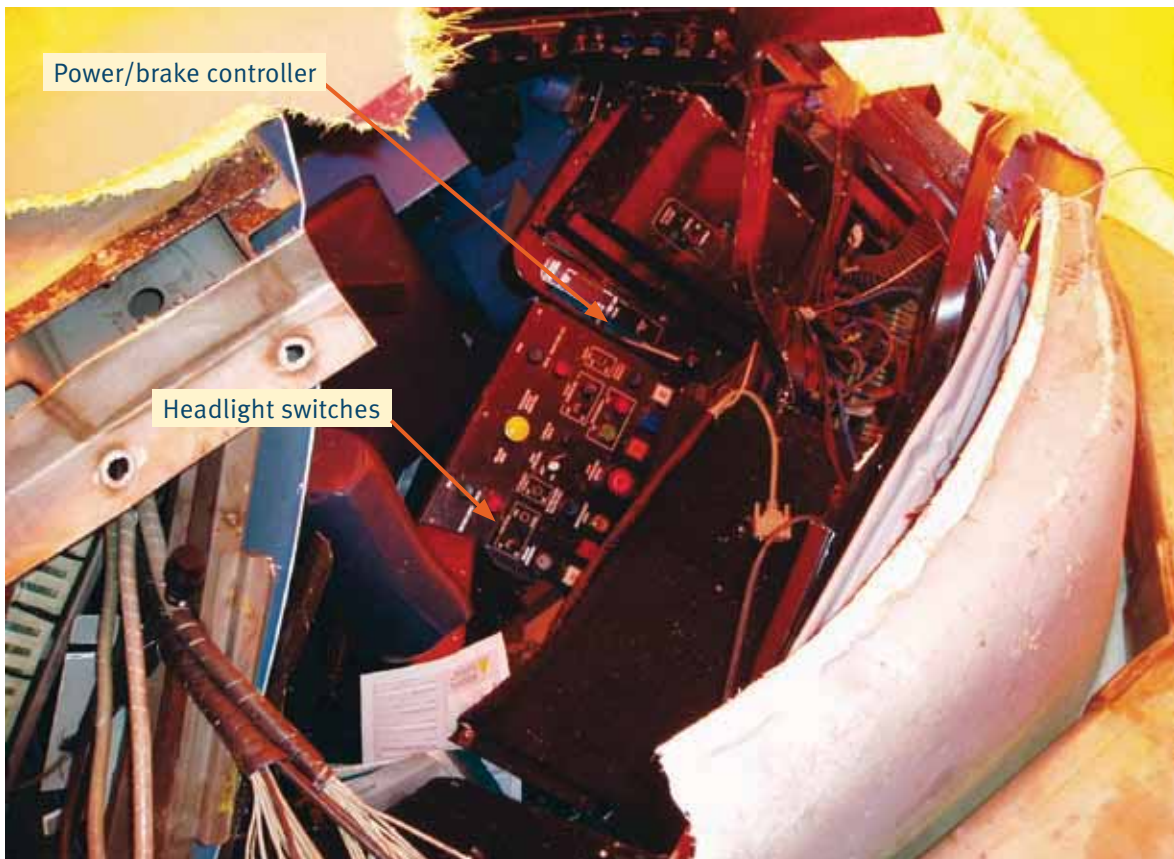
Figure 22: Train driver's console as found

Figure 21 displays the timings of the train controls based on the TMS data and figure 22 shows the train driver's console as found on site. The forward position of the brake handle indicates it is in the emergency position; the far right-hand toggle switch indicates that the headlight switch is in the 'on' position (up is on) and the toggle switch to the immediate left indicates that the headlight switch is in the 'dim' position.

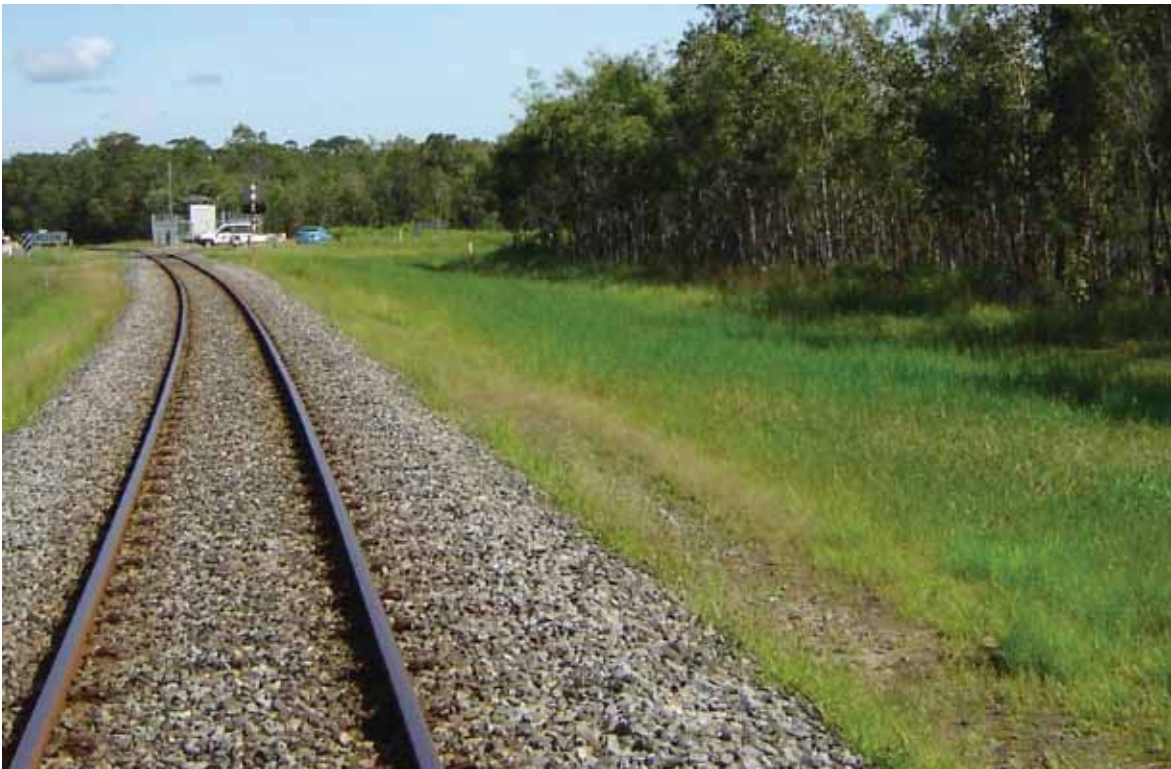
**Figure 25: View from track, about 100 m from crossing**

If the B-double truck was sighted by the train drivers at this point then the truck would have to be travelling at about 28 km/h which is clearly at odds with the other evidence.

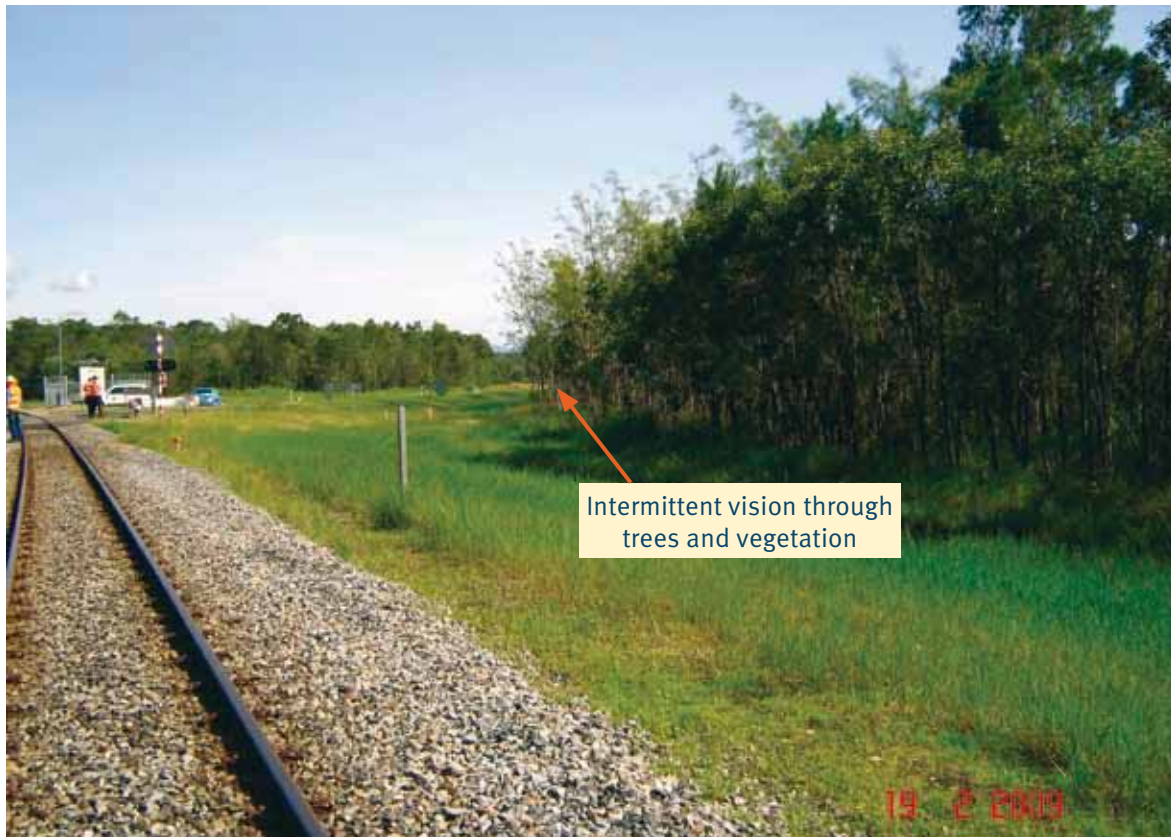
Figure 26: View from track, about 50 m from crossing

Given the sighting restrictions of road traffic approaching from the north, it is almost certain that the sounding of the train horn at 63 m (four seconds) from the level crossing is indicative of the train driver's point of perception of the truck rather than when the train was 103 m (6.5 seconds) from the level crossing.

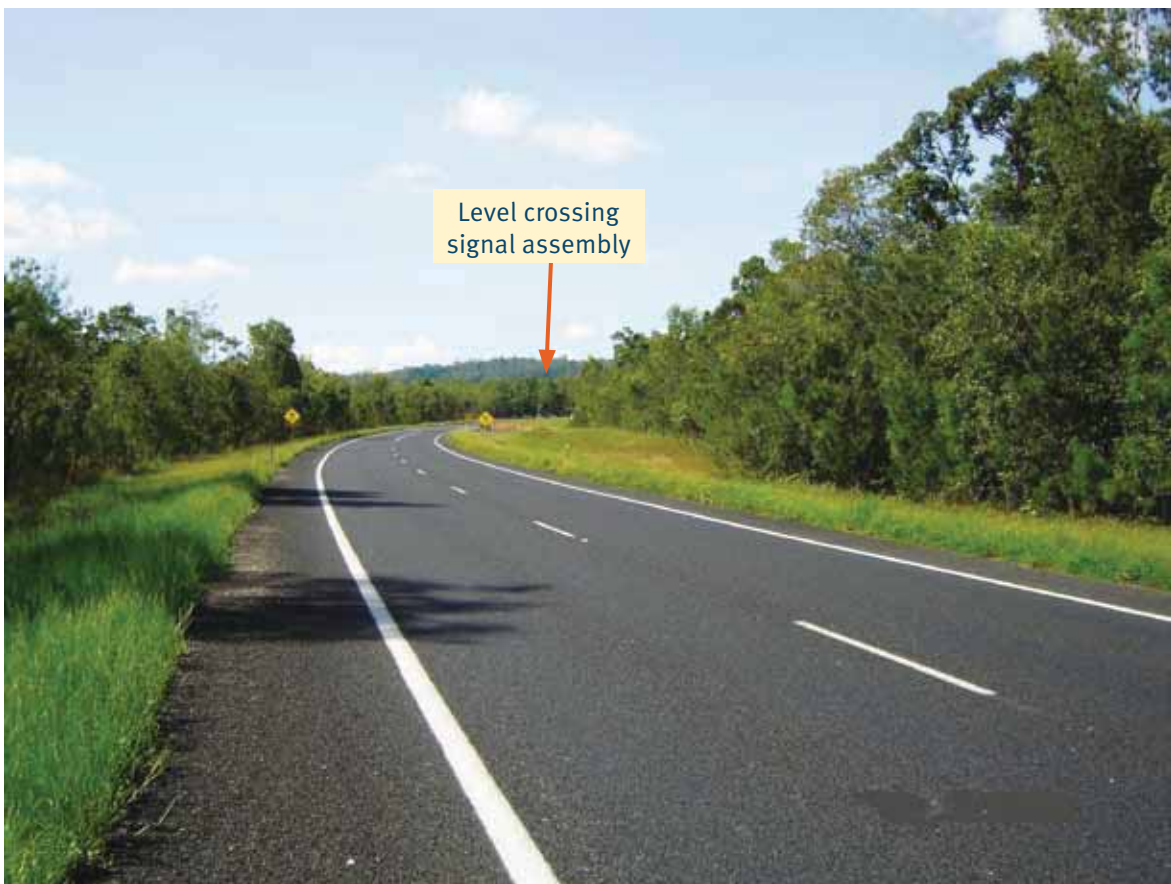
**Figure 30: First sighting of level crossing signal assembly (Southbound)**

At the Rungoo level crossing the southbound approach along the Bruce Highway was examined. It was found that the RX 5 level crossing signal assemblies (flashing lights) were clearly visible to a southbound vehicle from a measured 385 m from the level crossing (figure 30). Also, there were no impediments to the sighting of the advance warning signs or road markings. In addition, the windscreen of the prime-mover was found to be clean and relatively clear of cracks and chips.

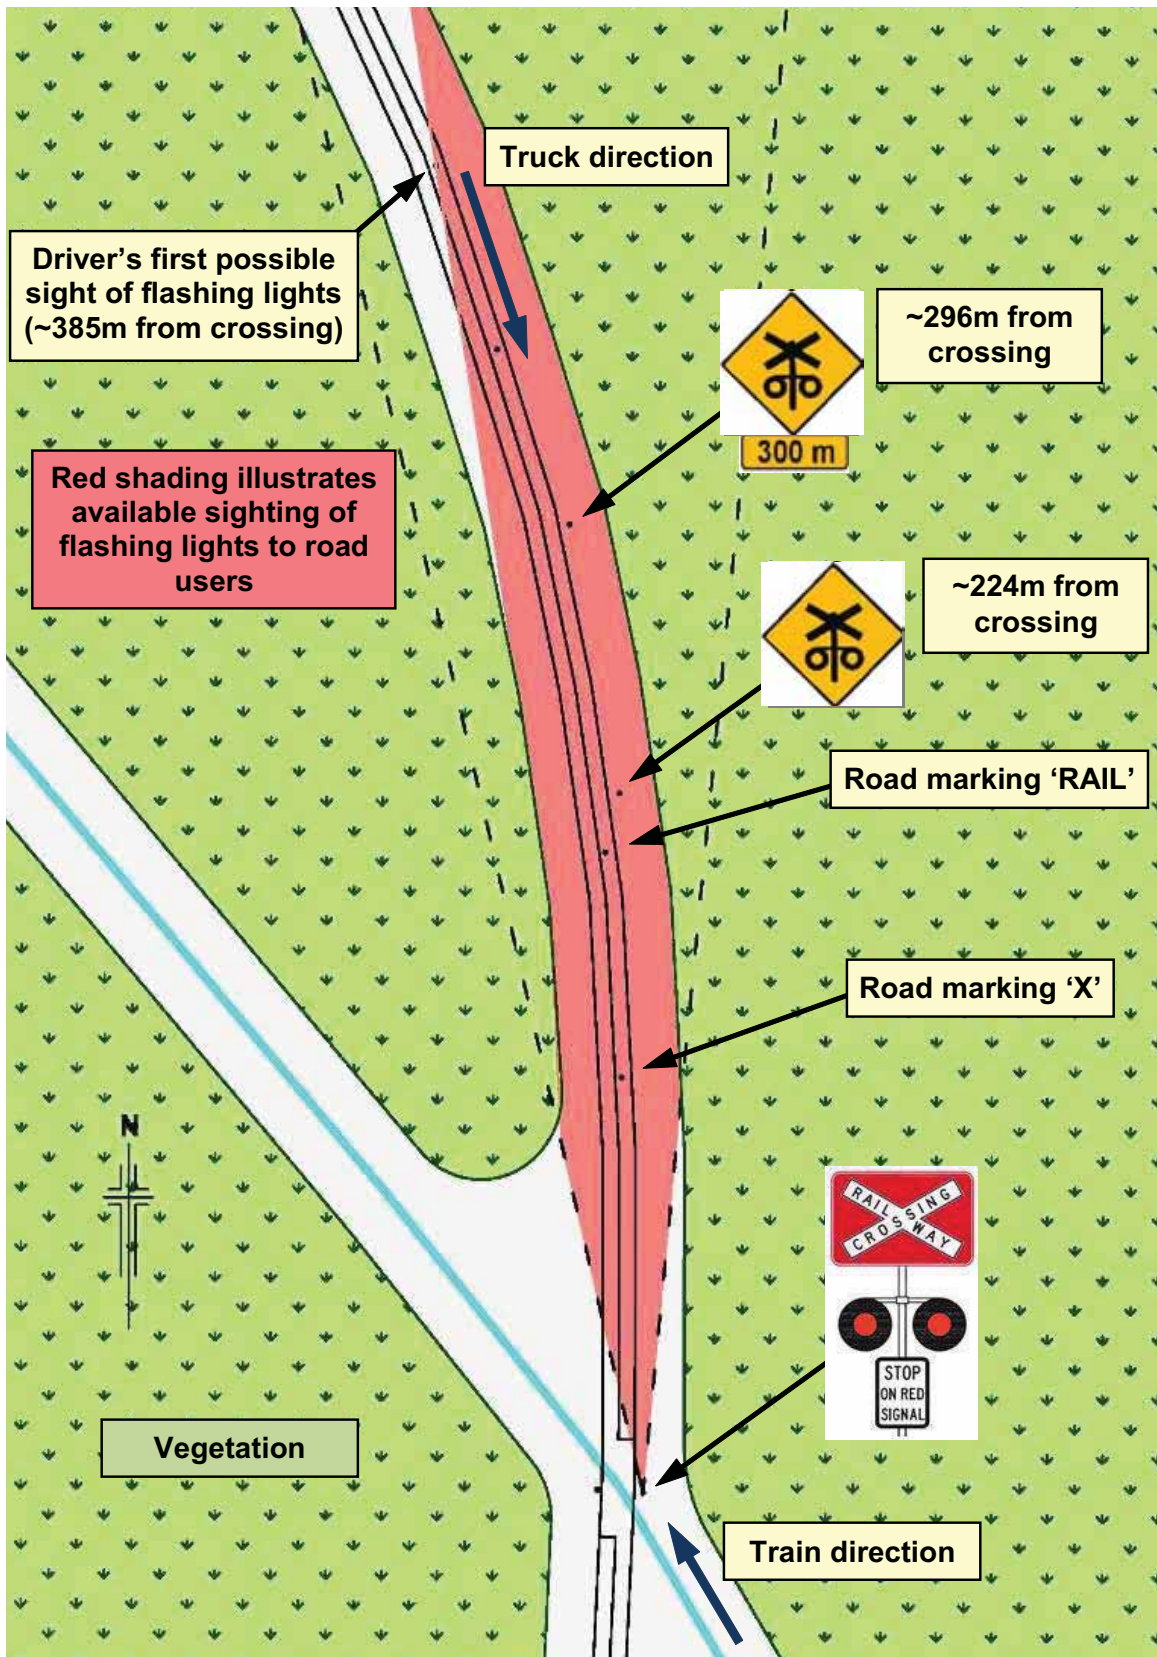
Figure 32: Sighting of north facing flashing lights, Rungoo level crossing

Figure 32 is a schematic representation of the spread of light from the LED light signal at the Rungoo level crossing at the time of the collision. This representation is based on the QR Network Flashing Lights Locality Plan for the Rungoo level crossing. The alignments of flashing light signals at level crossings are checked annually. This inspection was carried out at the Rungoo level crossing on 6 June 2008 and all components of the inspection were satisfactory.

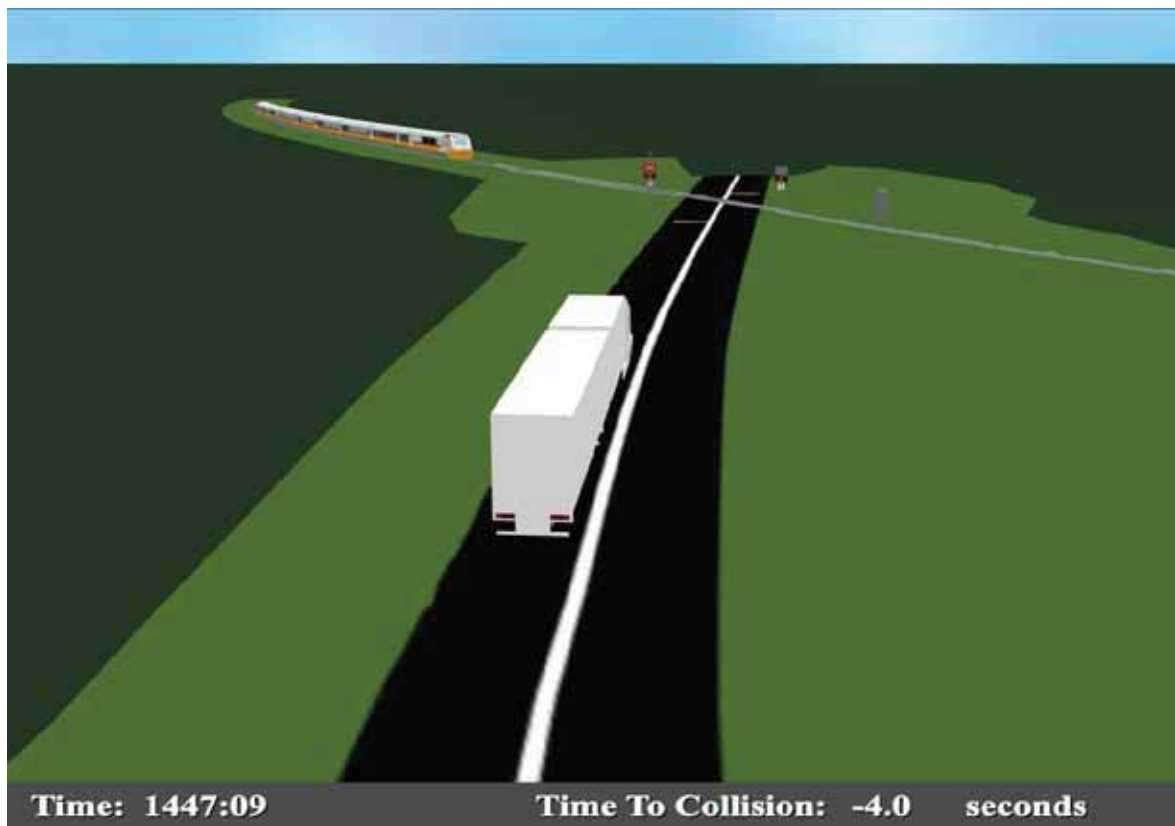
**Figure 33:** *Train – Truck position four seconds before impact*

It can therefore be concluded that, given the nature of the crossing and the speed of the two vehicles, the truck driver could not have visually detected the presence of the CTT and stopped before entering the Rungoo level crossing.

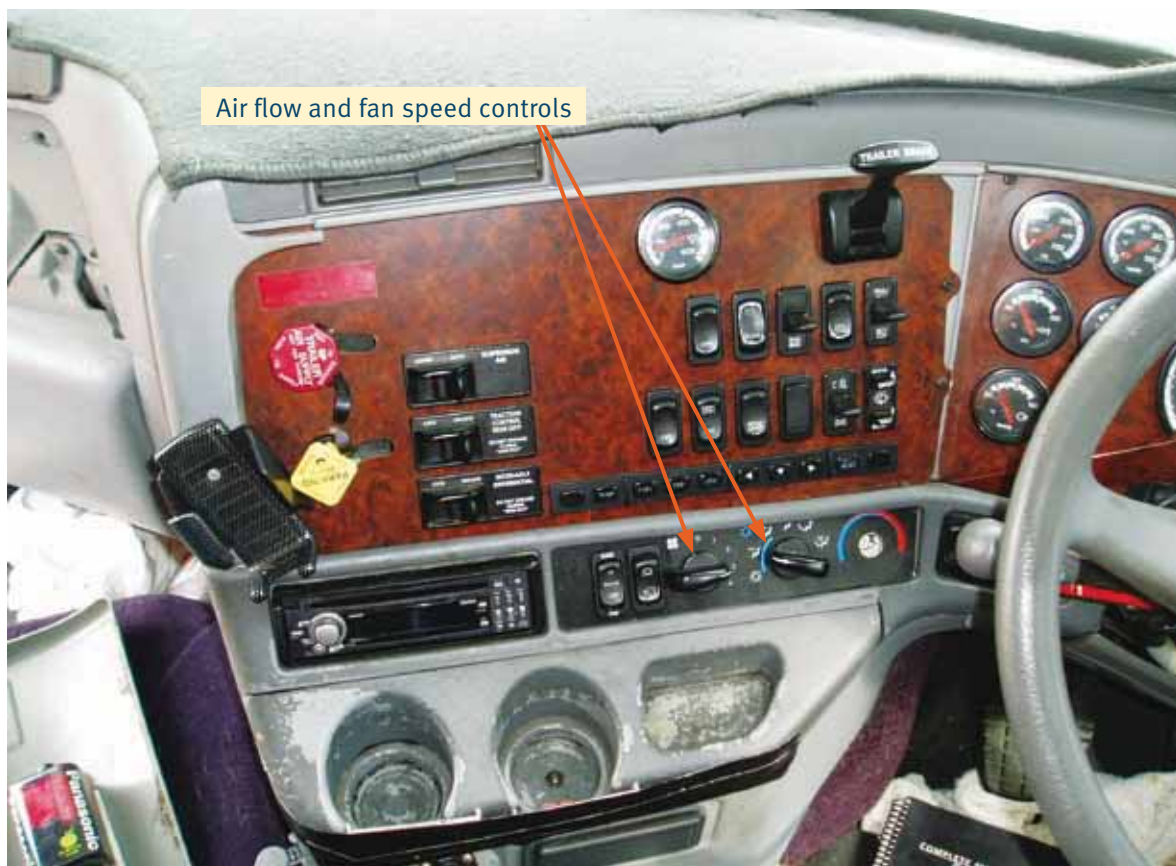
**Figure 36: Truck console at crash site. Note air-conditioning setting**

The QPS reported that the CB radio was turned on, however, the truck driver reported that the CB radio was off before the collision. He also reported that he was not using his mobile telephone at the time of the collision. A review of the truck driver's phone records confirmed that he did not have any incoming or outgoing calls before the collision.

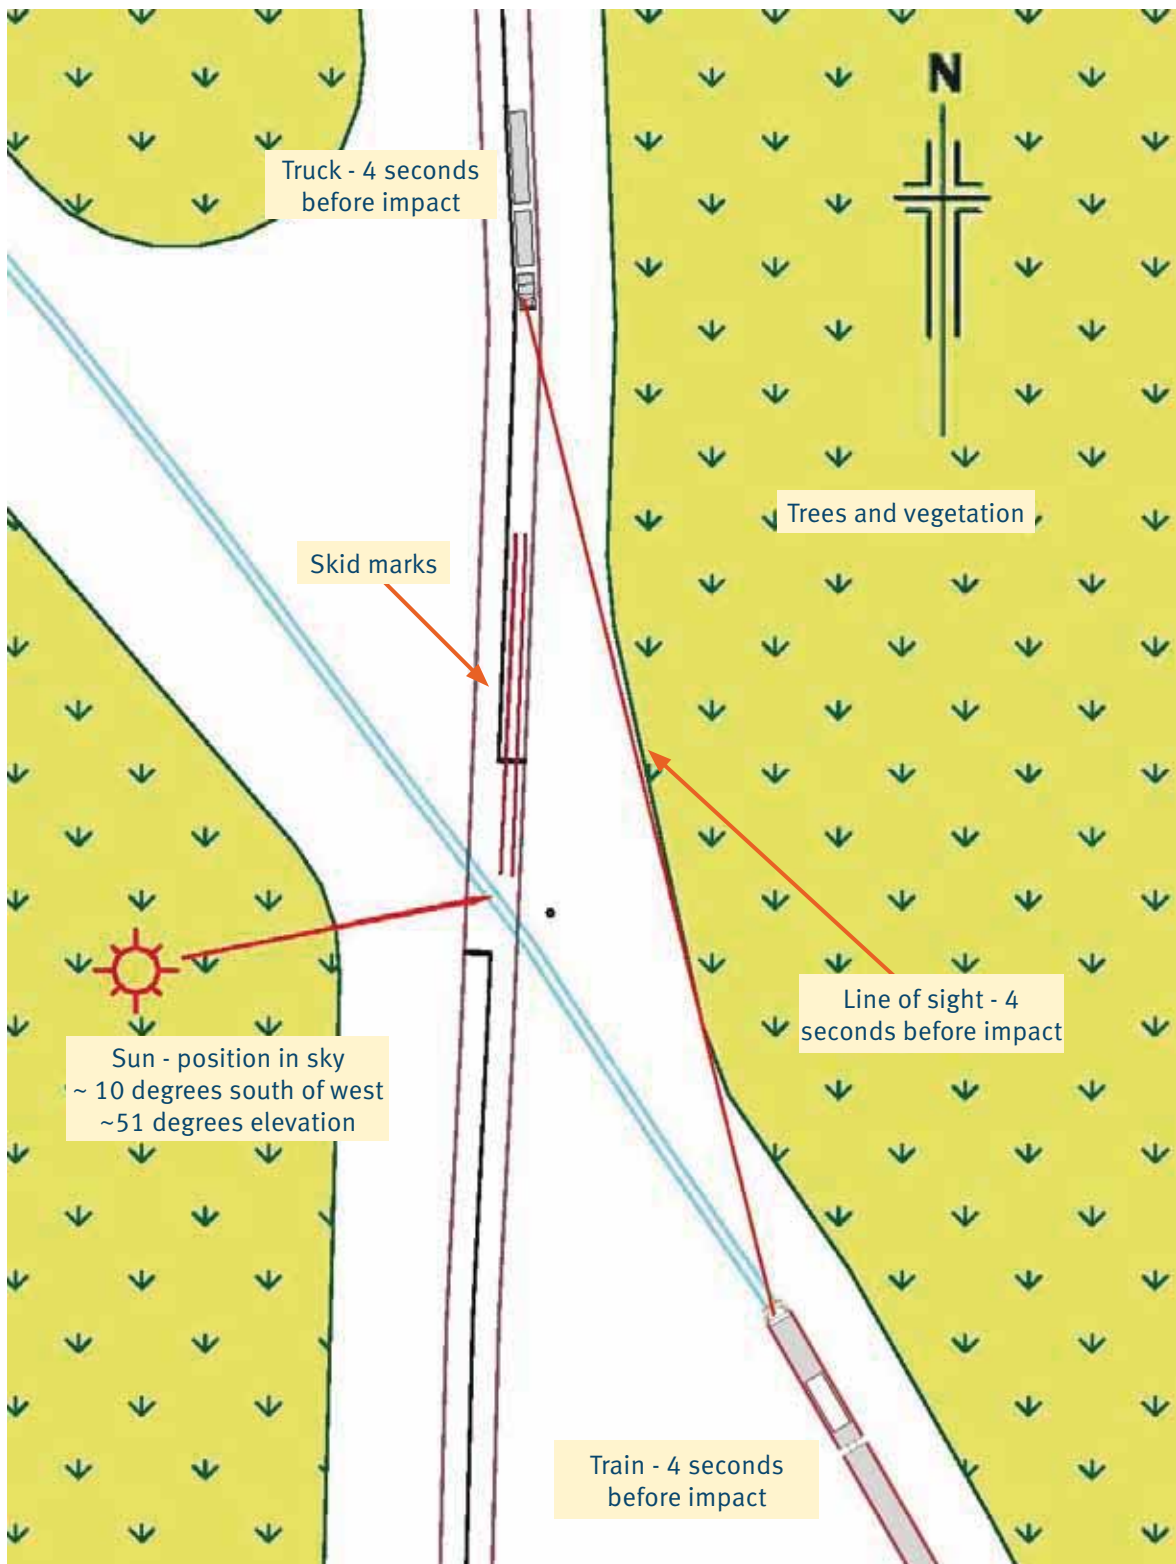
Figure 37: Train – Truck Sighting and position of sun

As discussed in section 1.1.5, information from witnesses indicated that at the time of the crash at the Rungoo level crossing there was predominantly fine weather with showers about the tops of the hills in the vicinity and an overcast sky. In addition, the road was described as being wet. As such, it is unlikely there were any significant reflections on the road or other surfaces outside or inside the truck cab which would have produced significant glare.

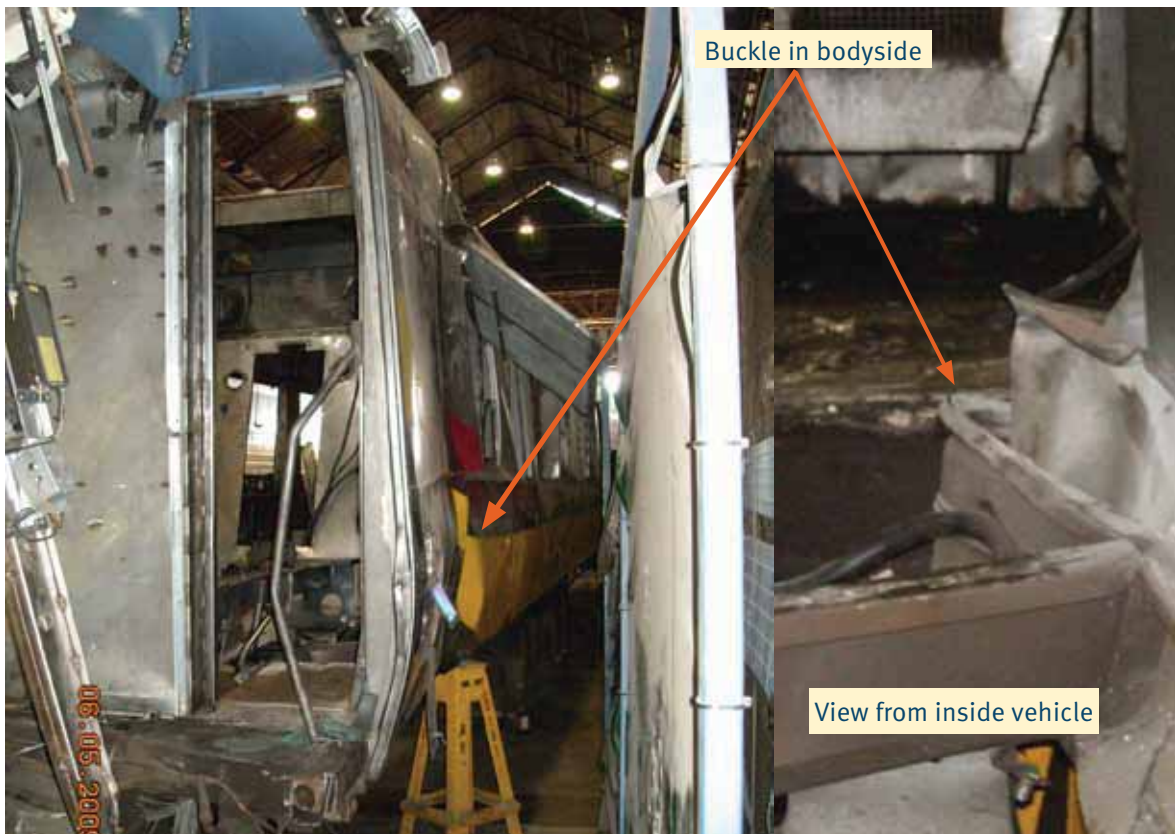
Figure 42: Solebar buckle

The lateral bending and compressive loading caused the left side of the power car body to buckle and the right side to bend. This combination of compressive and left side movement was responsible for the solebar failure on the left side and not on the right.
