SAND DUNES, SOILS AND WATER – IMPACTS OF MINING ON NORTH STRADBROKE ISLAND

Presentation to FAC
Parliamentary Committee
10 March 2016

Prepared by Dr Errol Stock

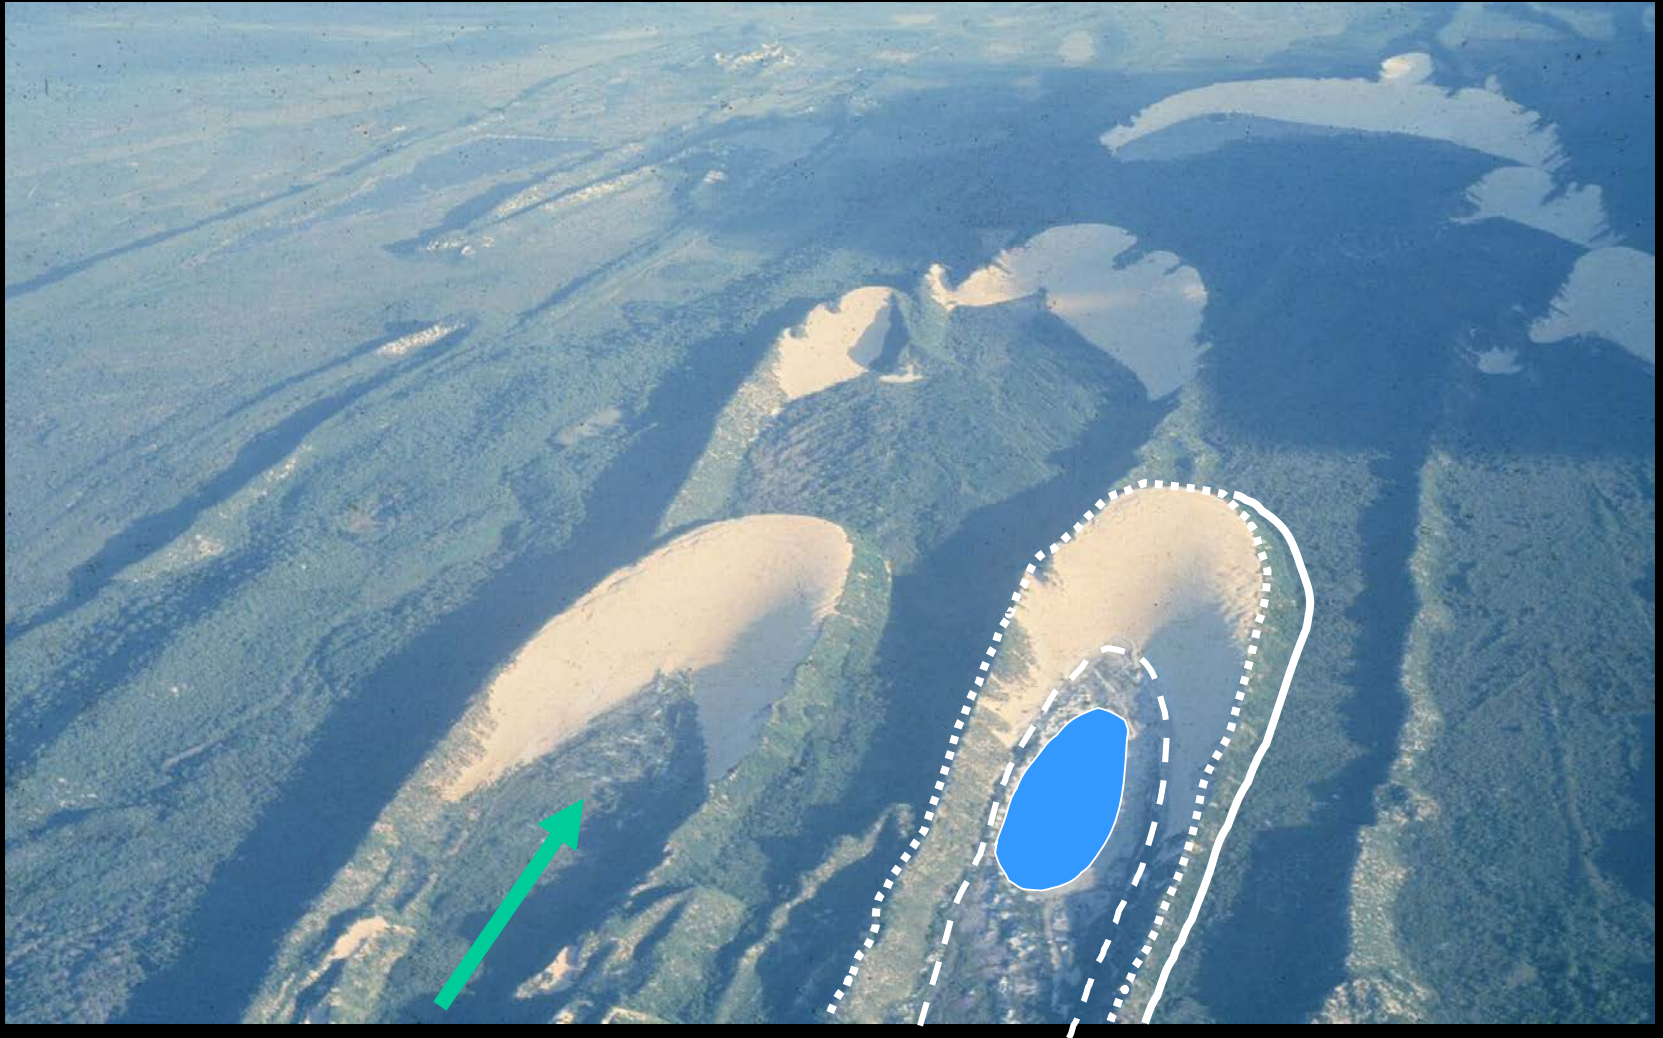
Series of active, large, elongate parabolic dunes, Cape Flattery, far north Queensland

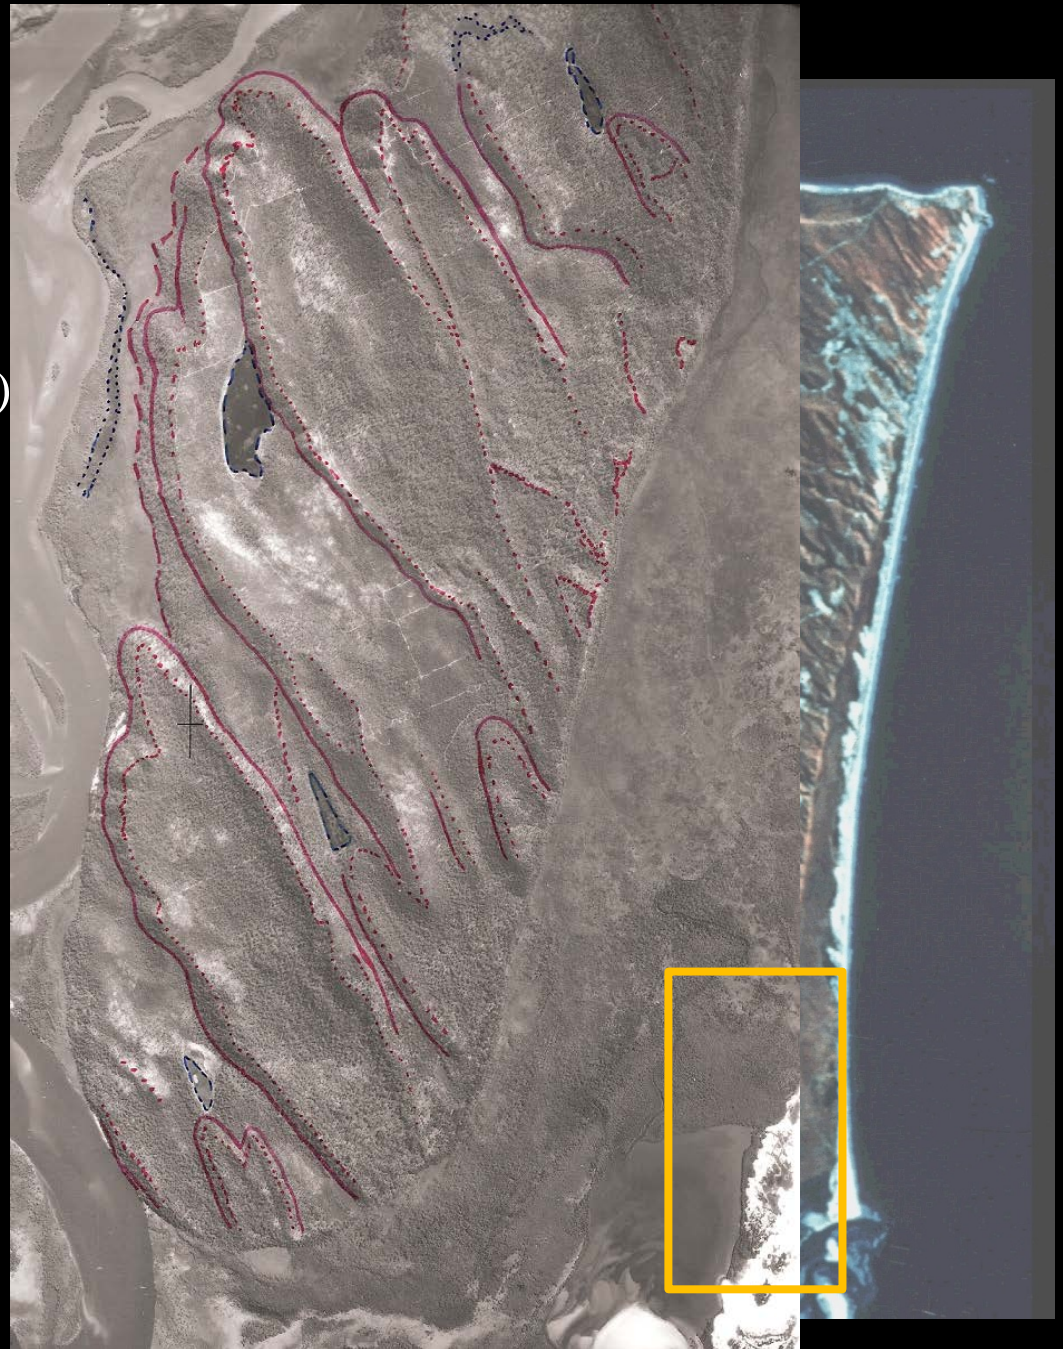
Southern NSI

Relict, large
parabolic dunes

1982 B & W aerial photo

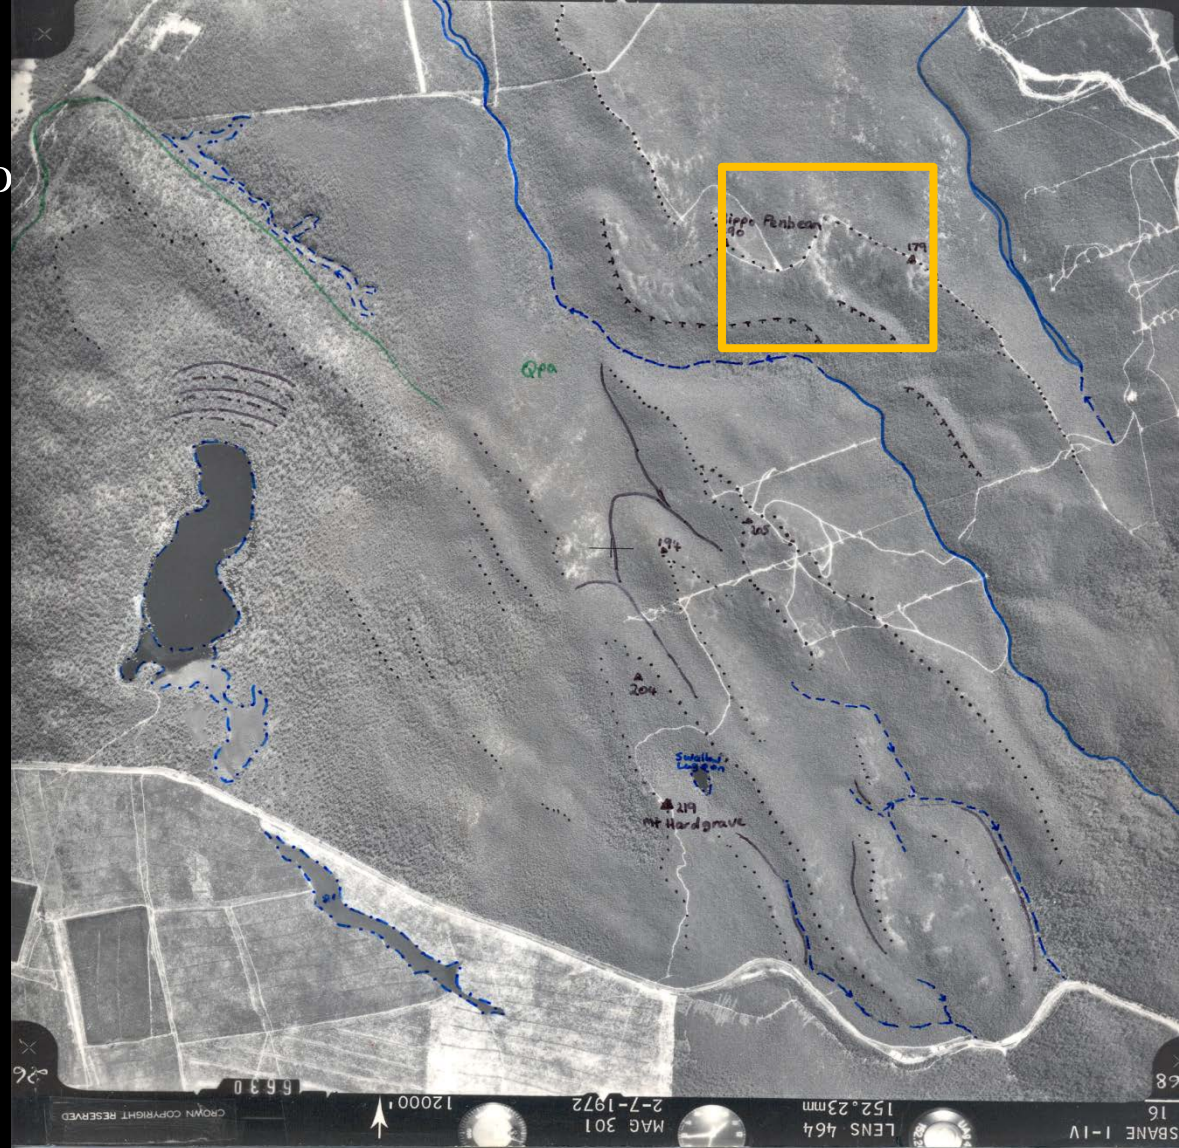
Northern NSI

NW-SE ridges
(relict after large
parabolic dunes)

1982 B & W aerial photo

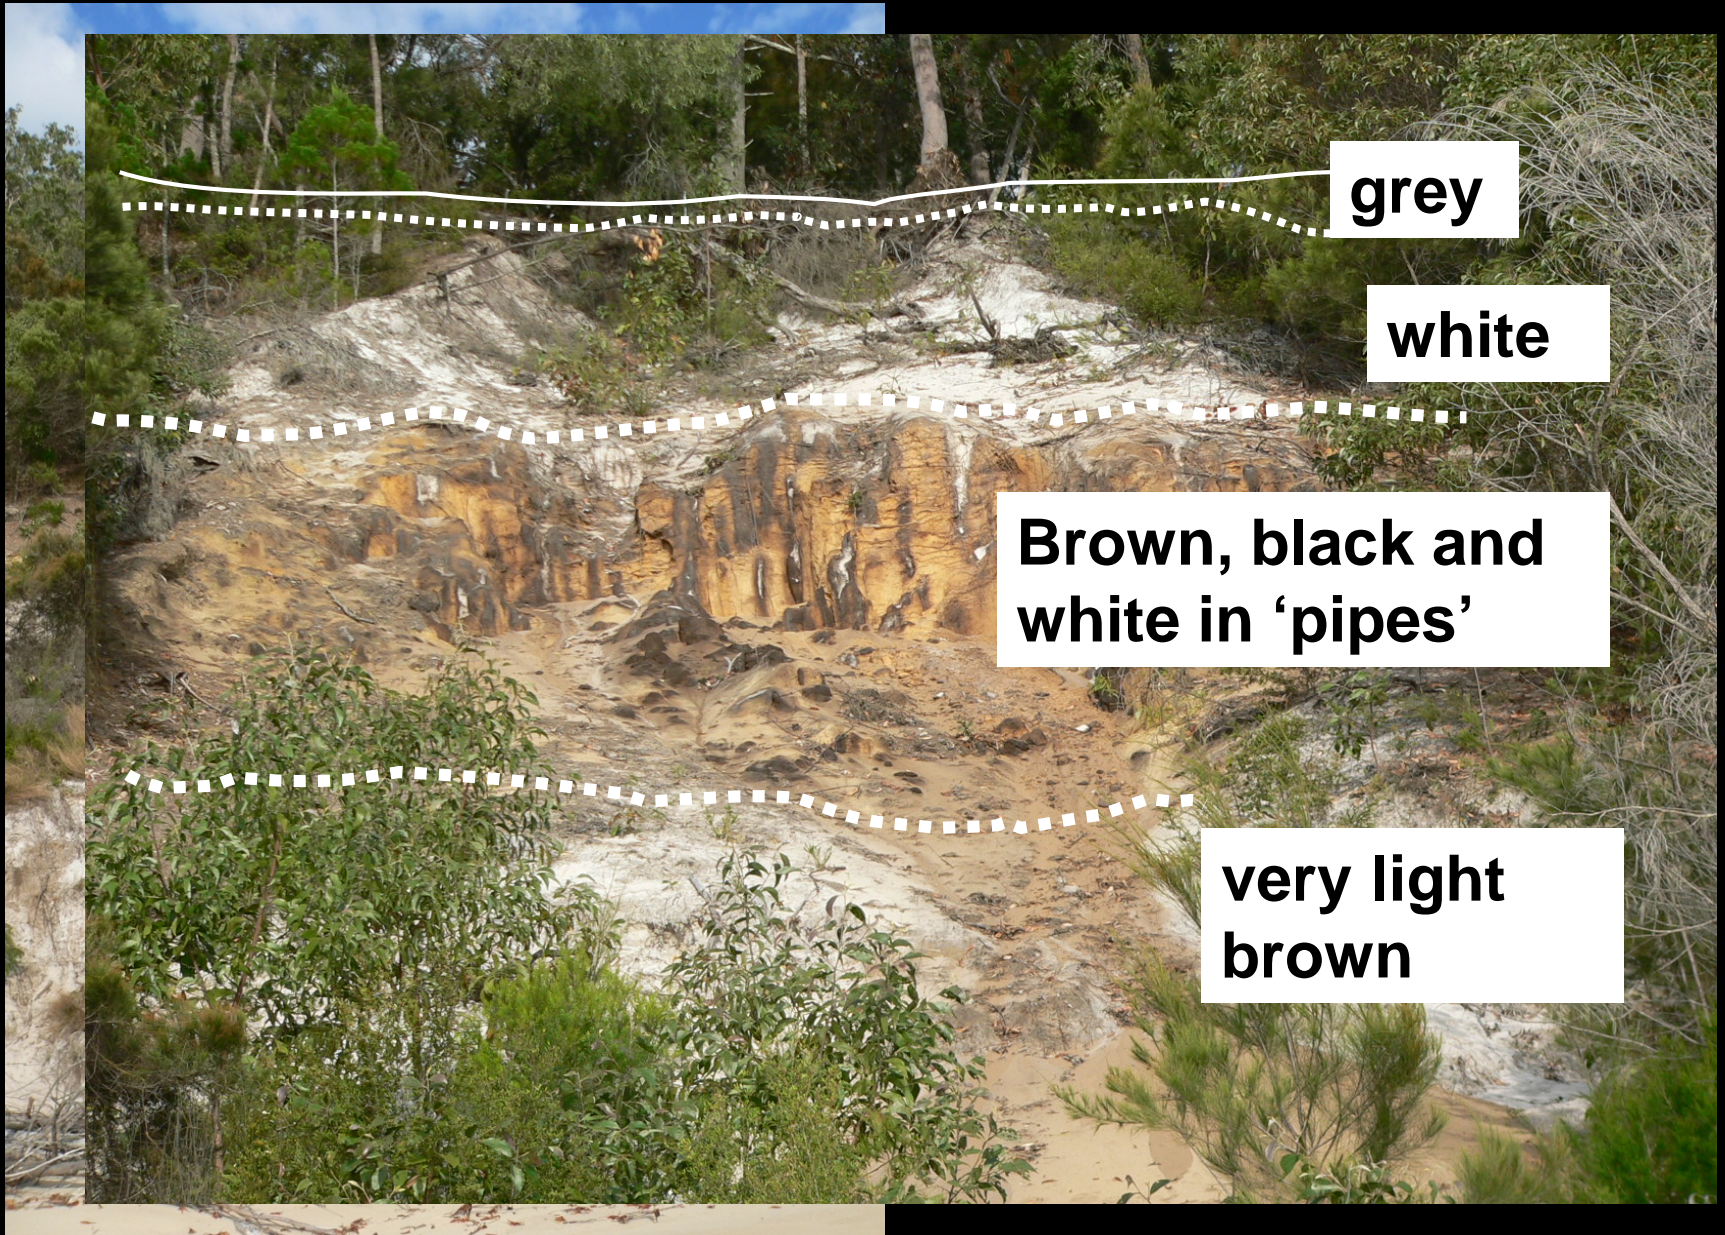
Deep siliceous podsol soil profile

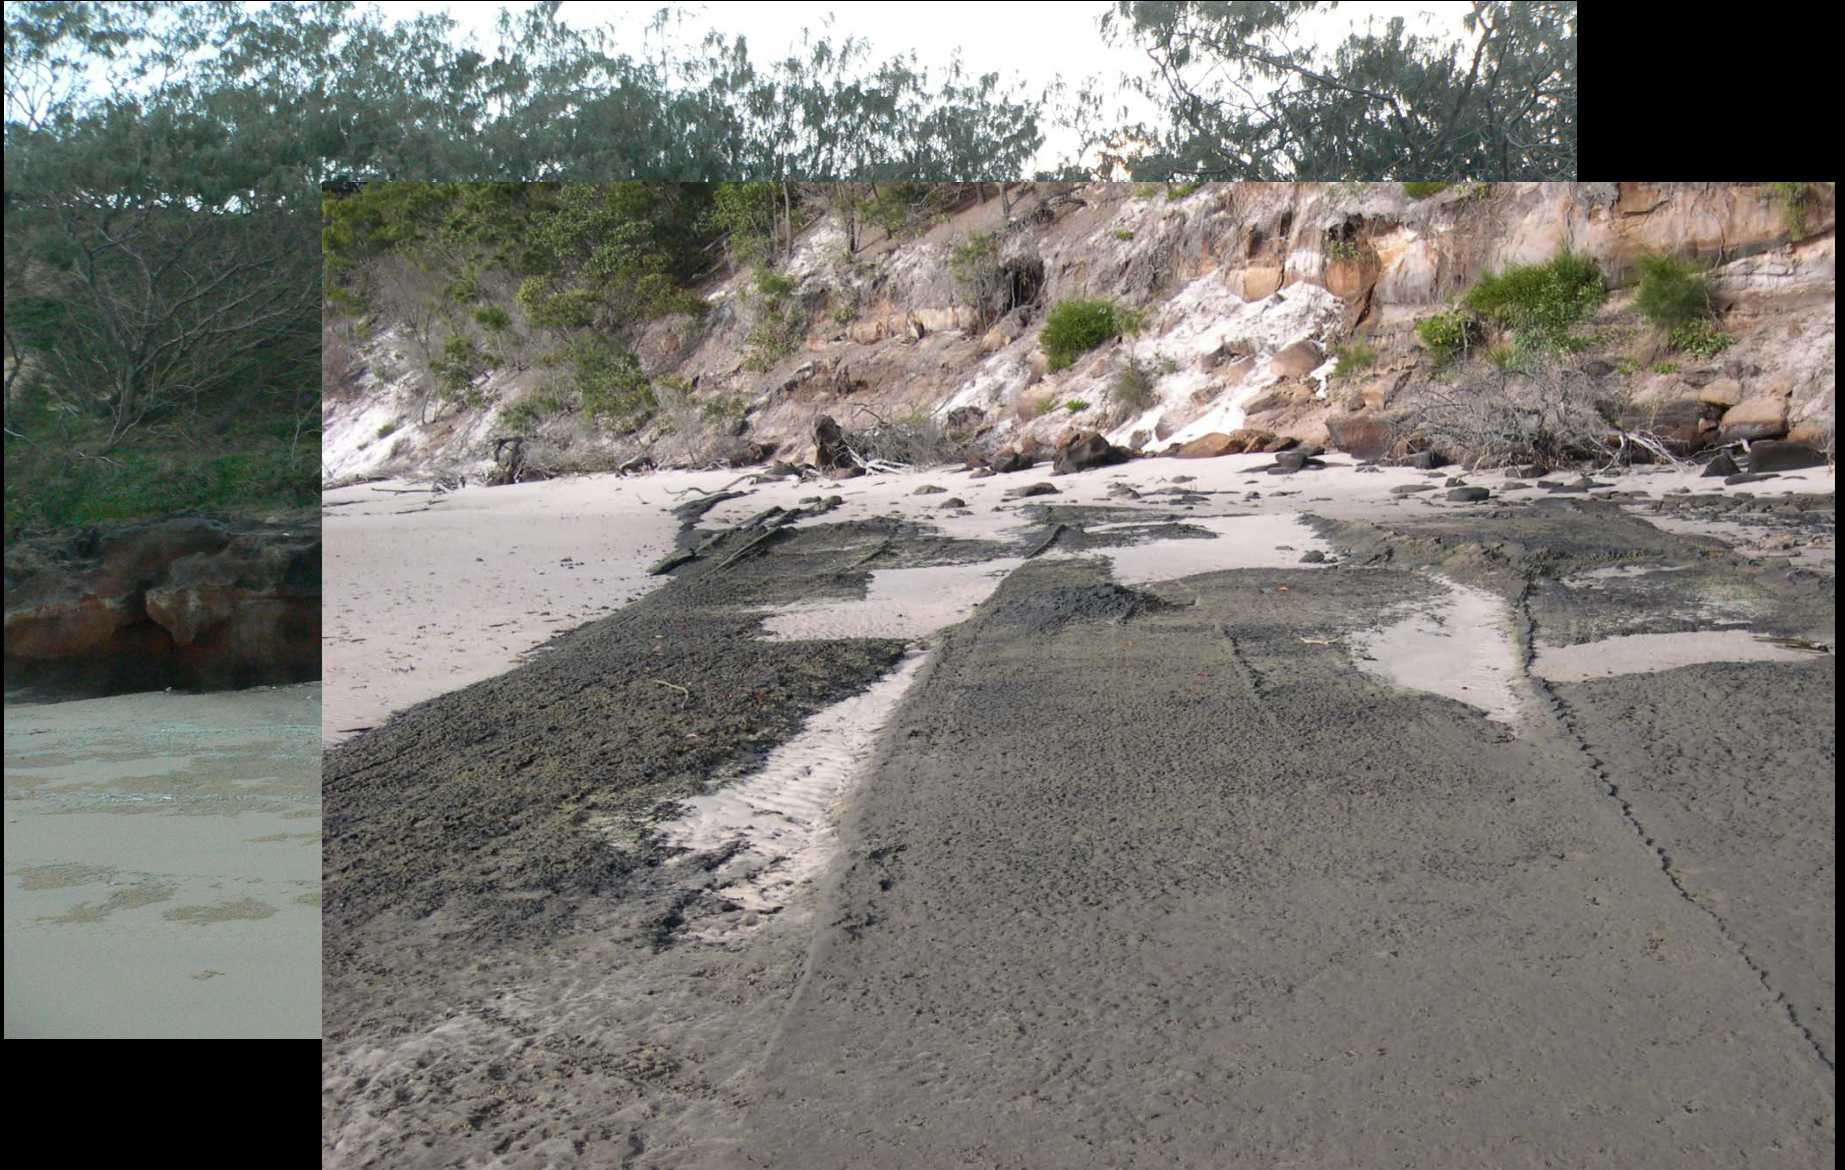
Examples of humic podsoles (Also called 'coffee rock', humicrete)

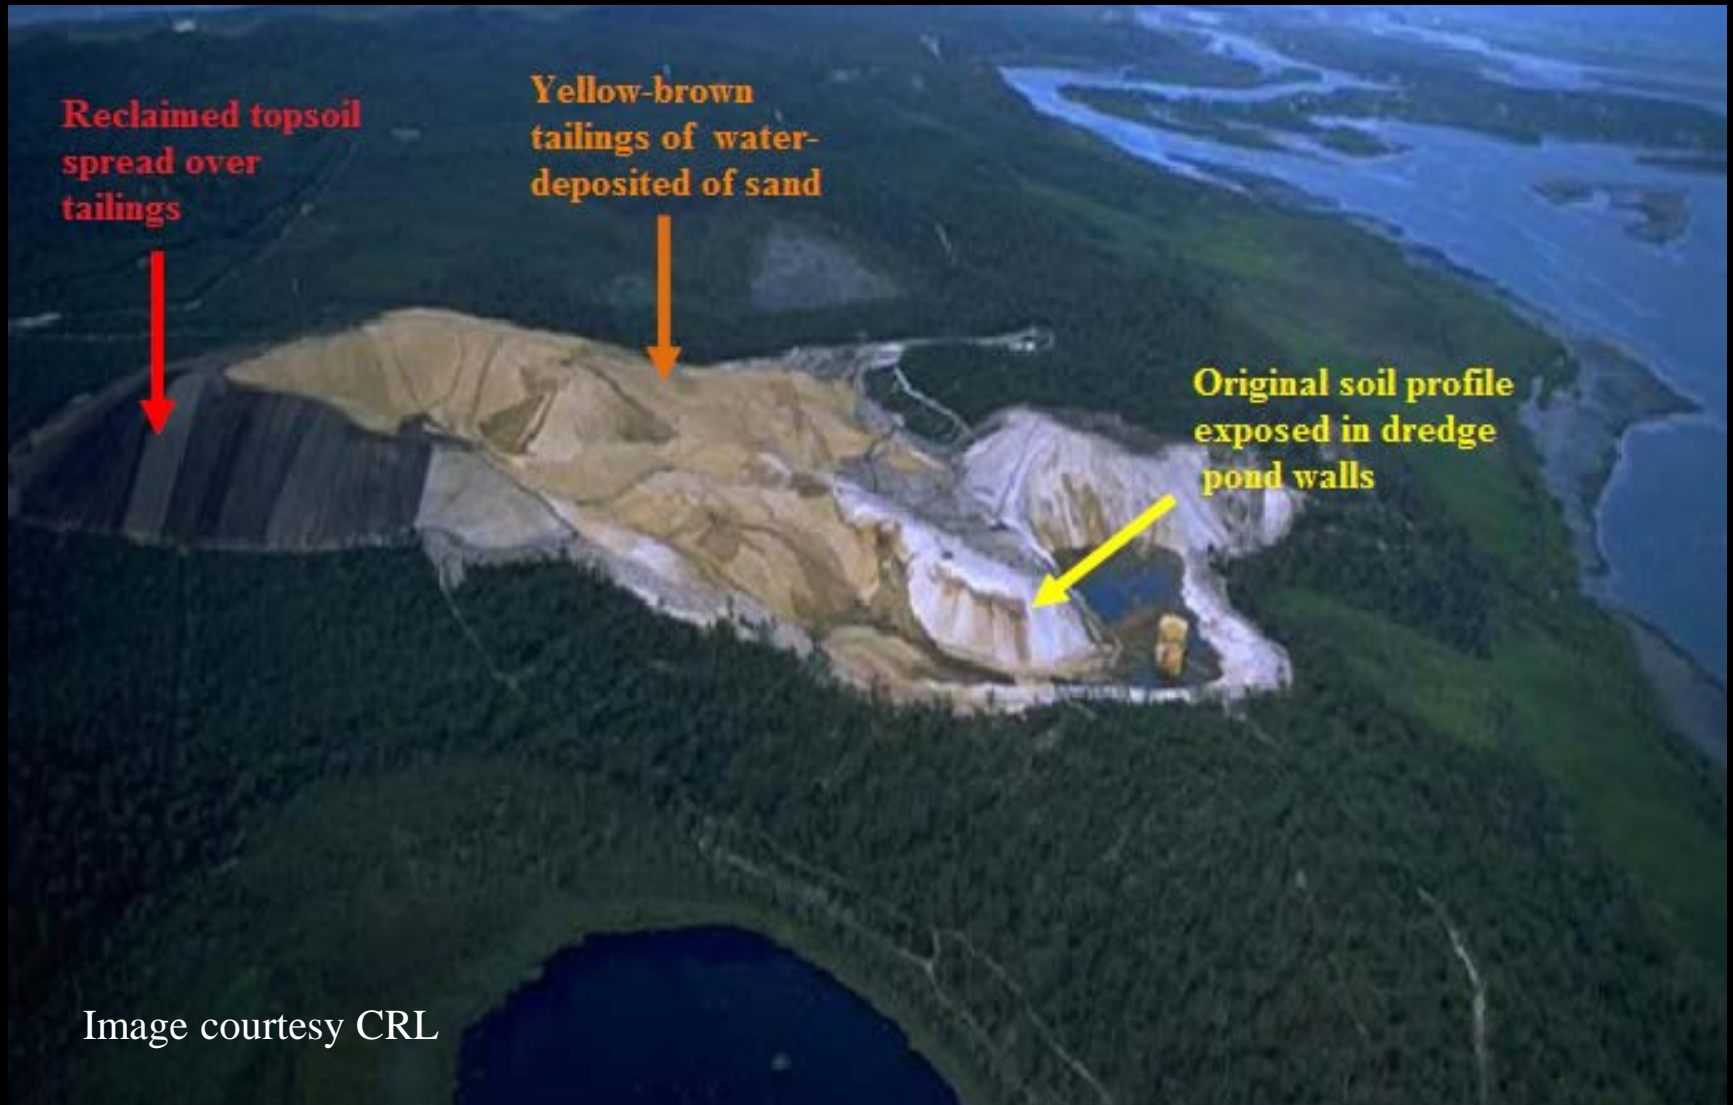
Basic mining and rehabilitation sequence at Gordon Mine

(view to S)

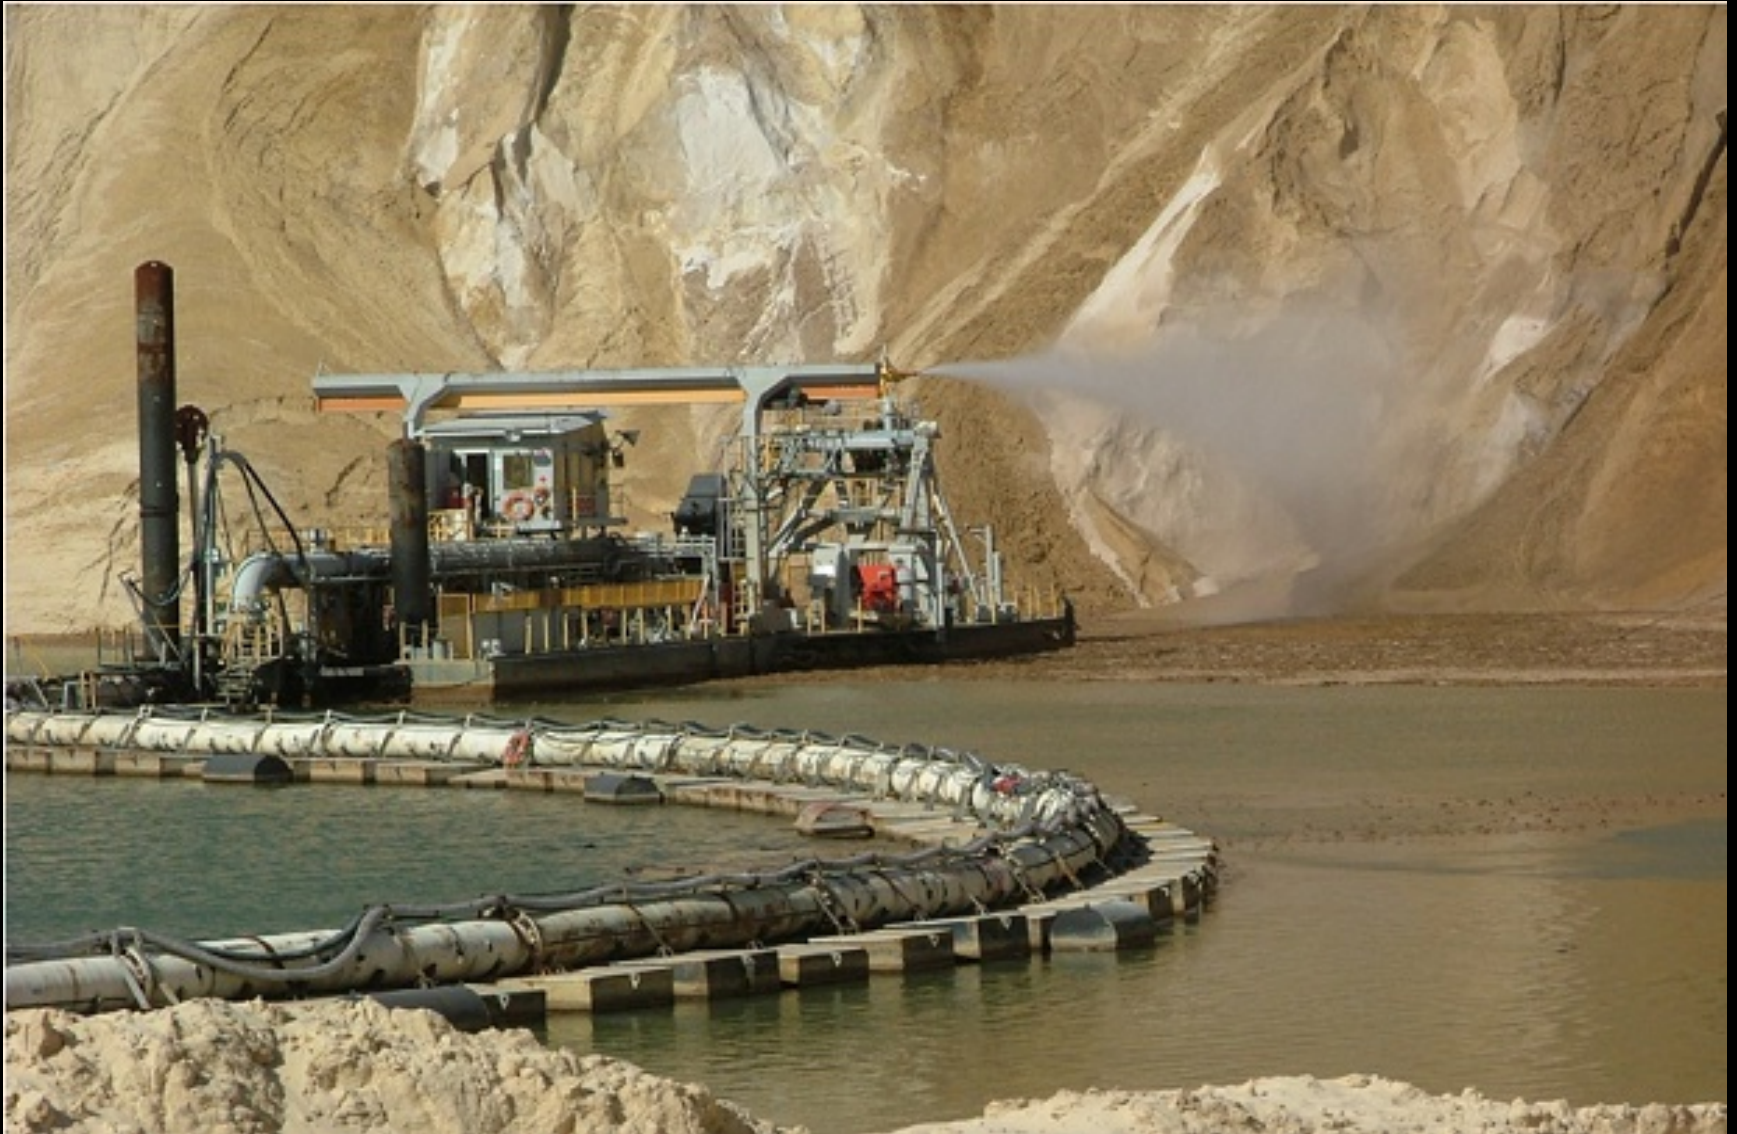
Water is involved throughout dredging and pumping sand to concentrator

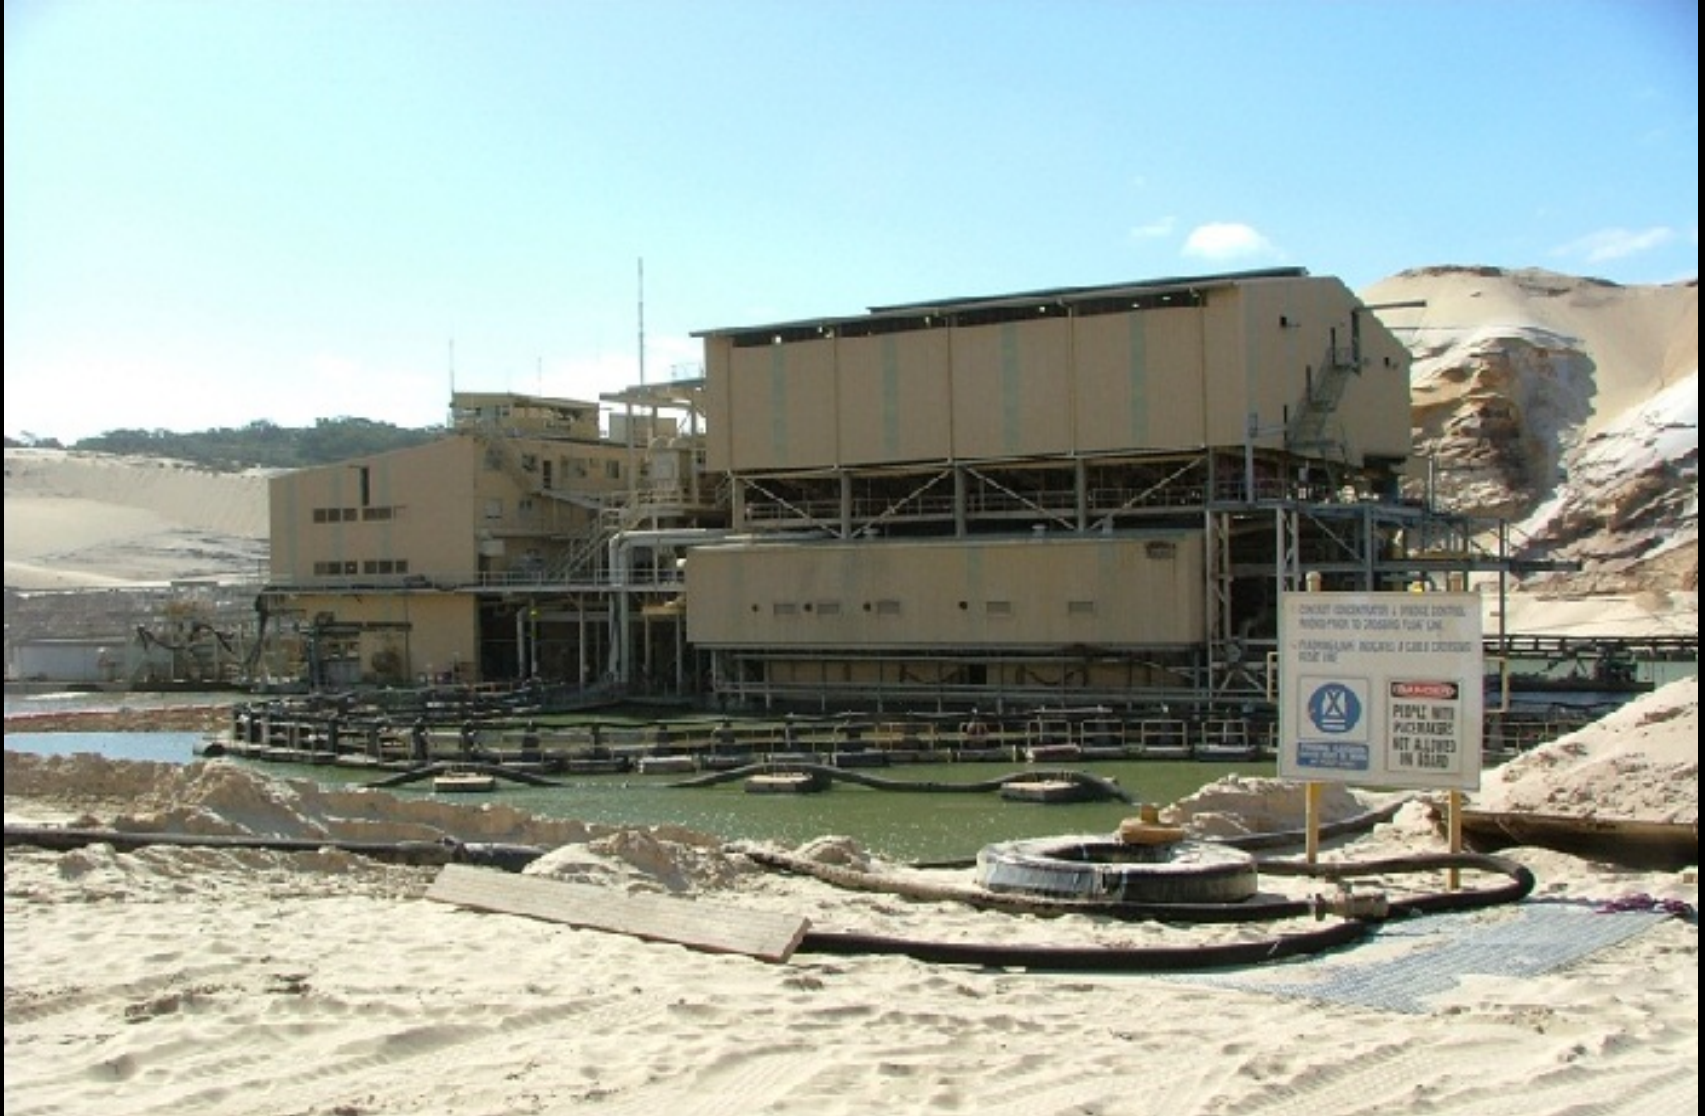
Floating concentrator generates mixed sands for tailings and separates mineral sand products

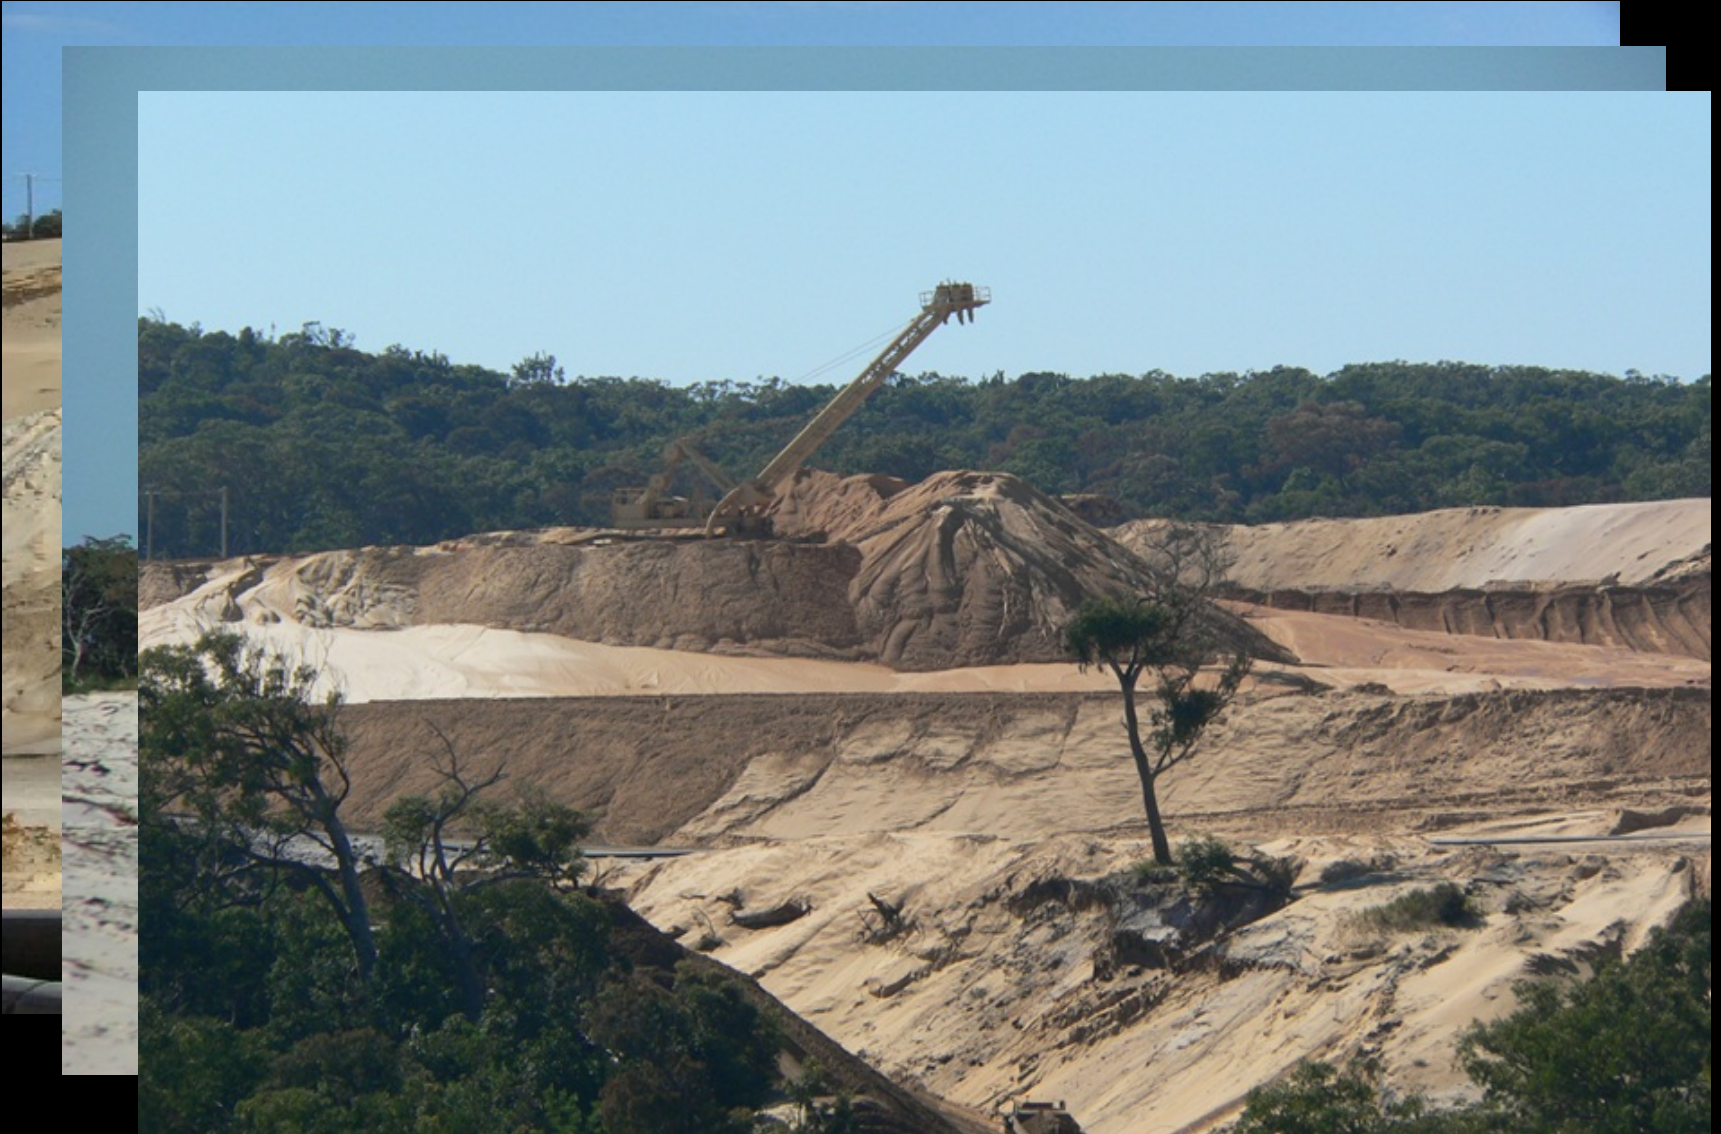
Yellow-brown sand tailings built up from many stacking positions

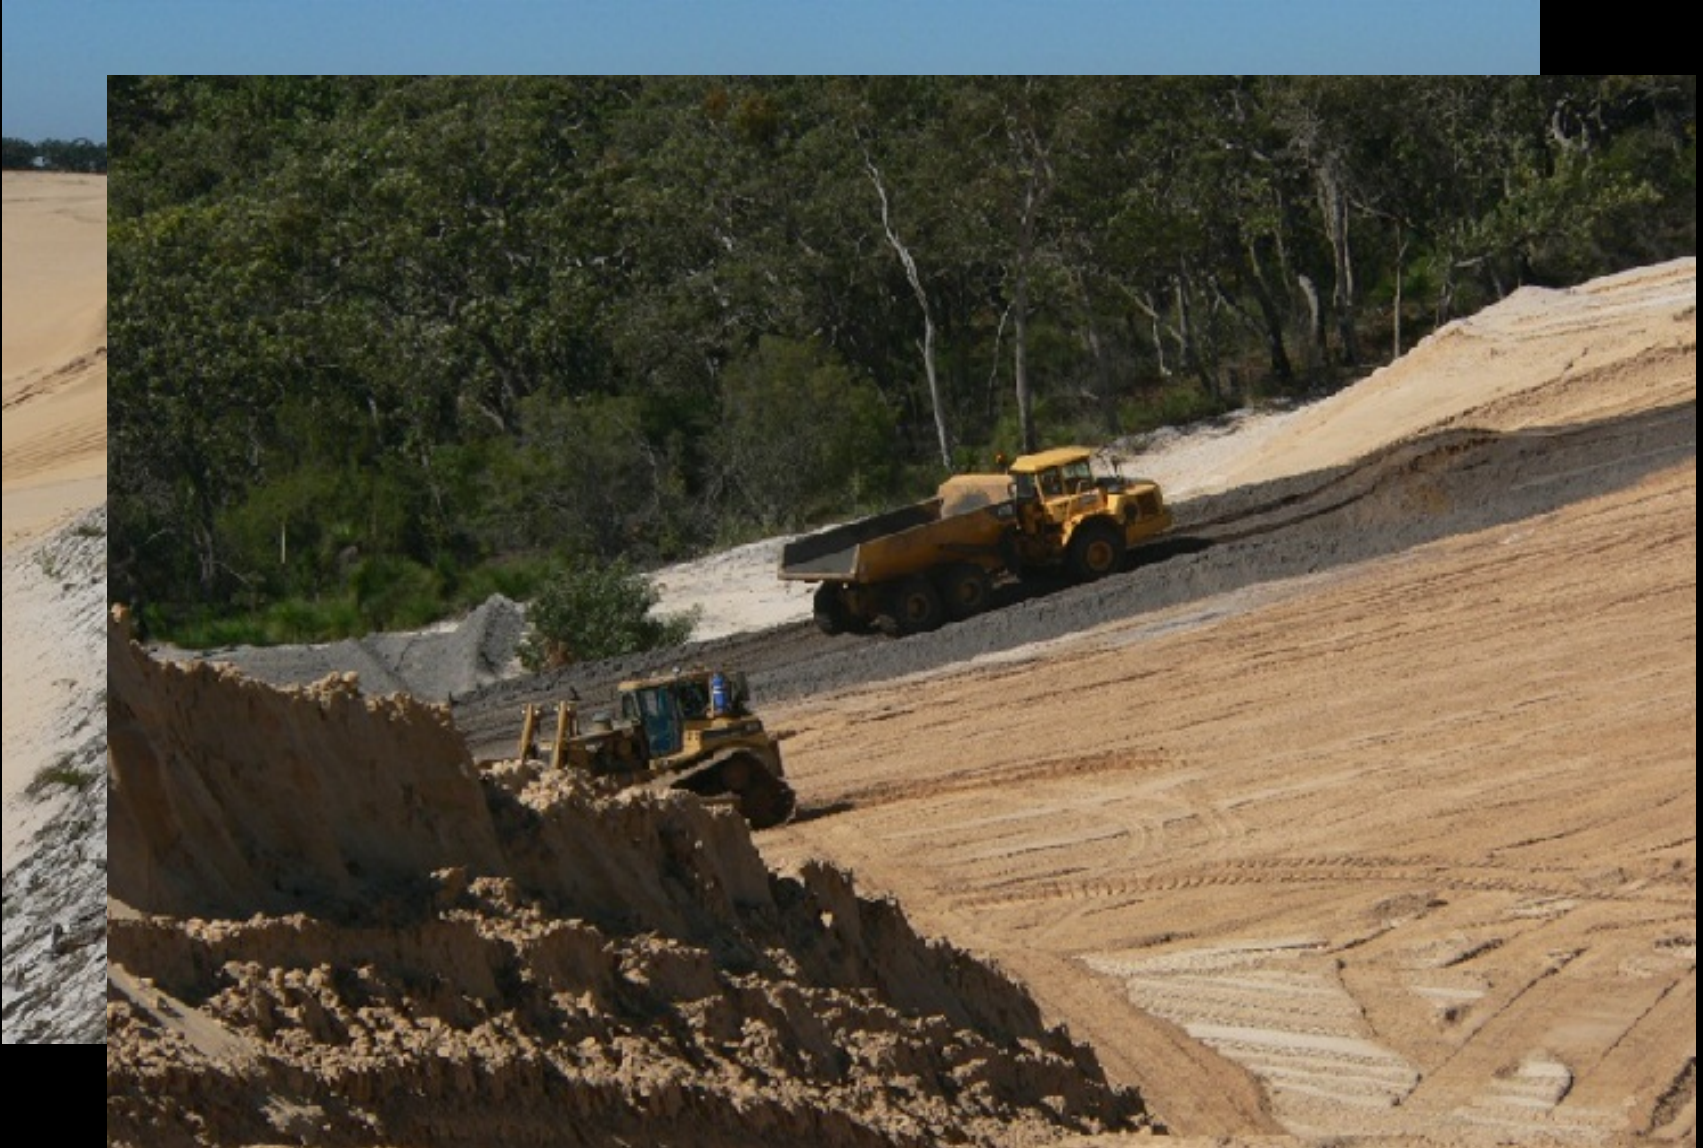
Stripped topsoil stored in stockpiles then reclaimed for spreading over dredge tailings

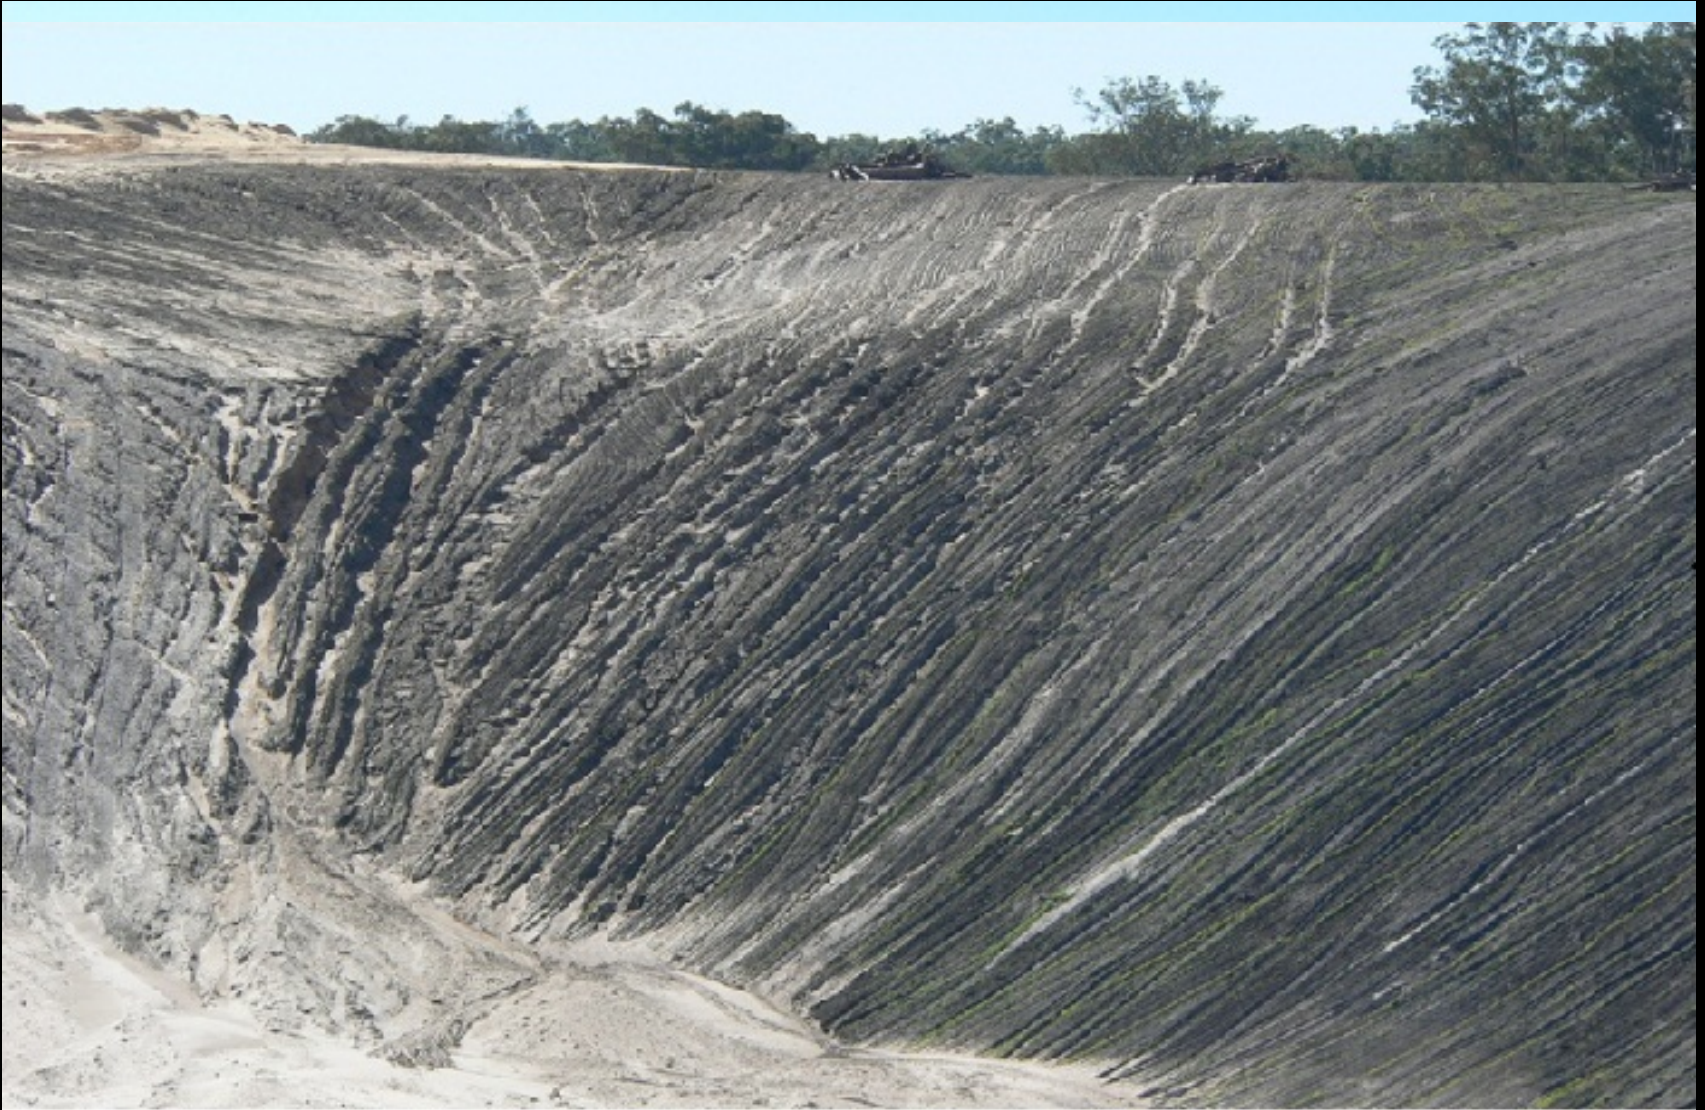
Reshaped topography with topsoil, but:
...erosion creates variable base conditions
for revegetation outcomes

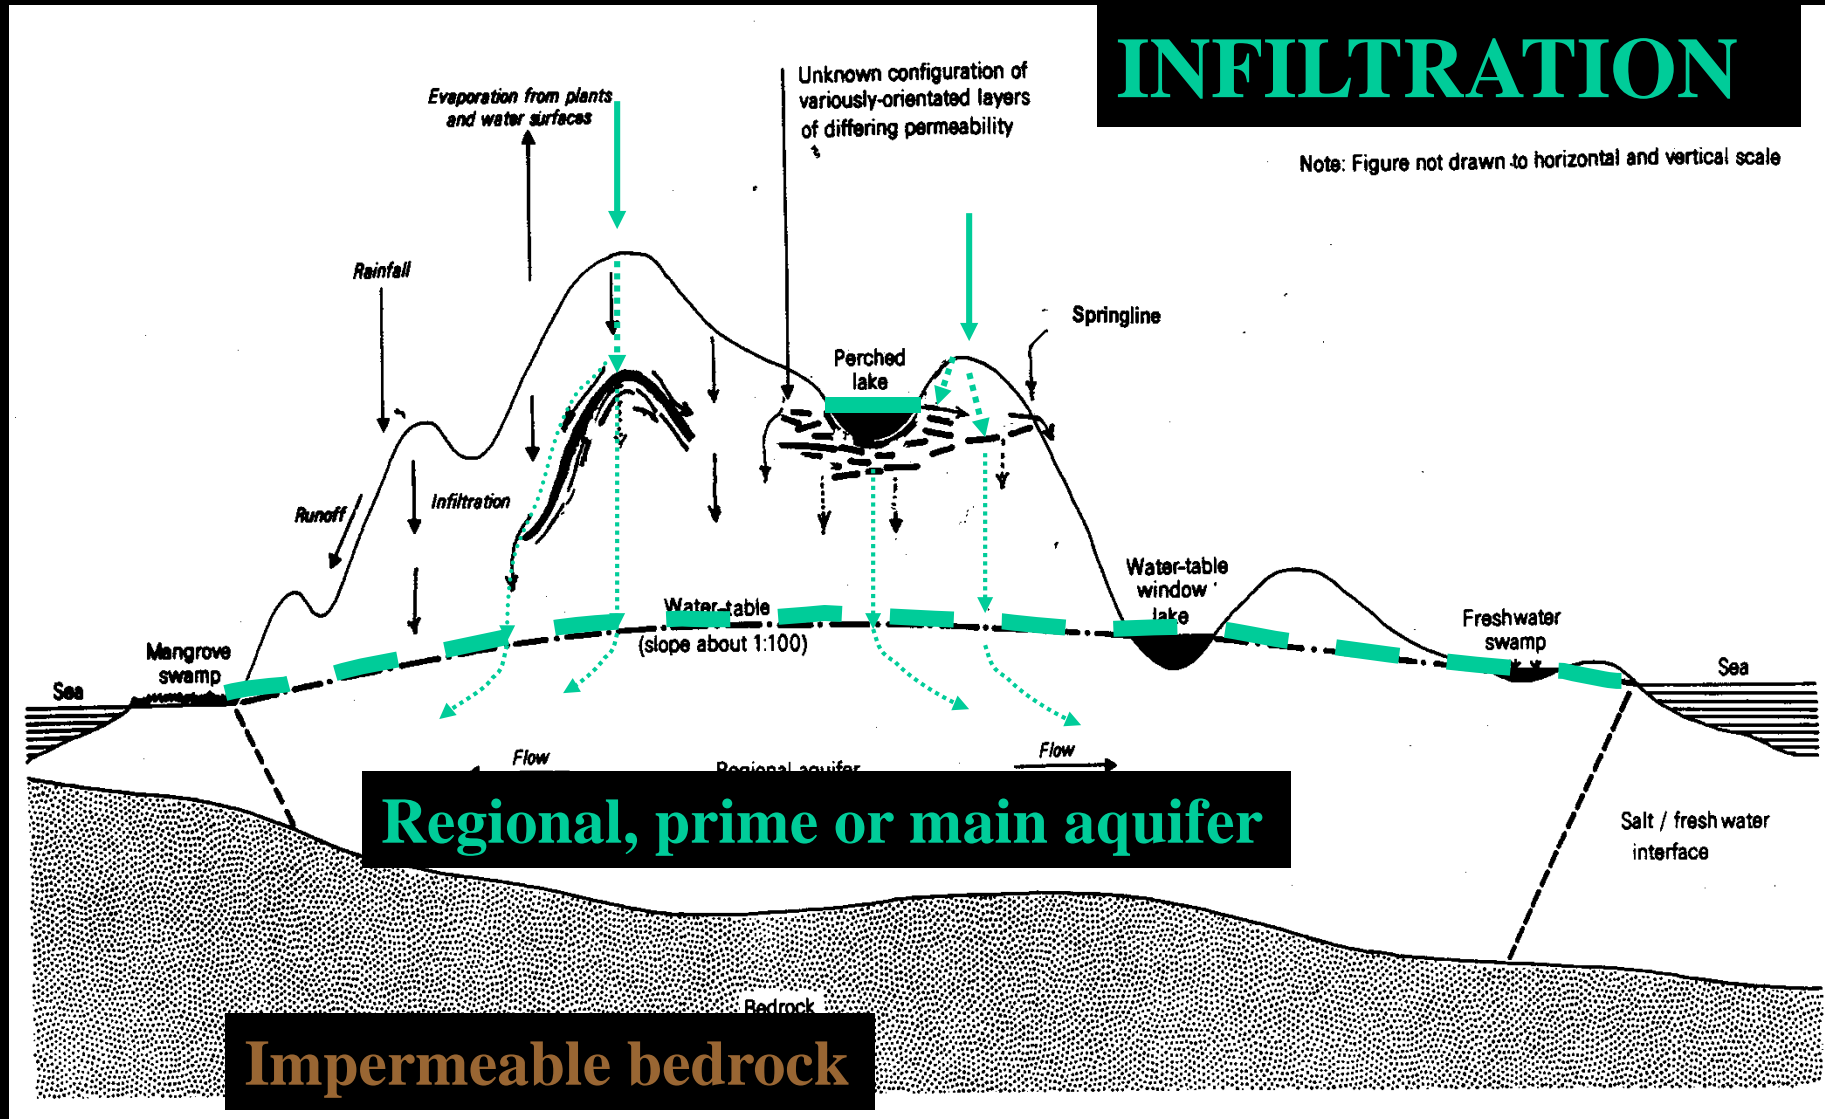
Diagrammatic cross-section of a typical sand island
