SAND DUNES, SOILS AND WATER – IMPACTS OF MINING ON NORTH STRADBROKE ISLAND

Presentation to FAC
Parliamentary Committee
10 March 2016

Prepared by Dr Errol Stock

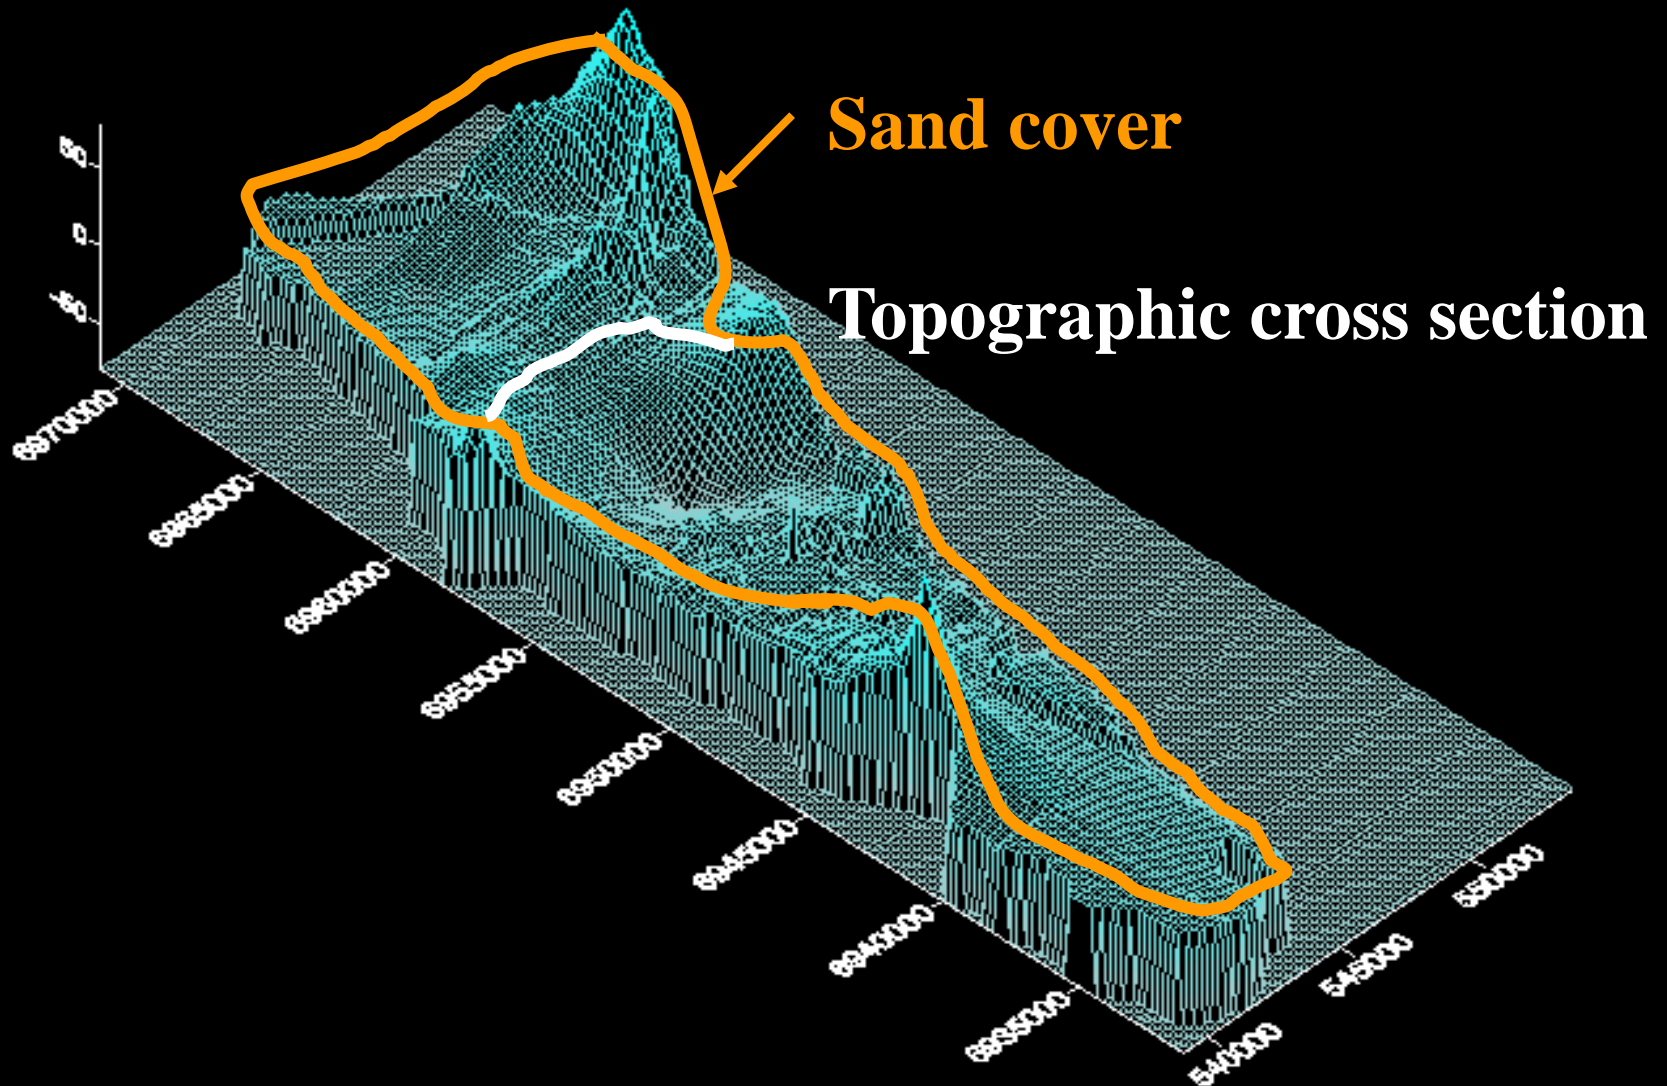
Bedrock topography and sand cover NSI

(Diagrammatic on wireframe perspective)

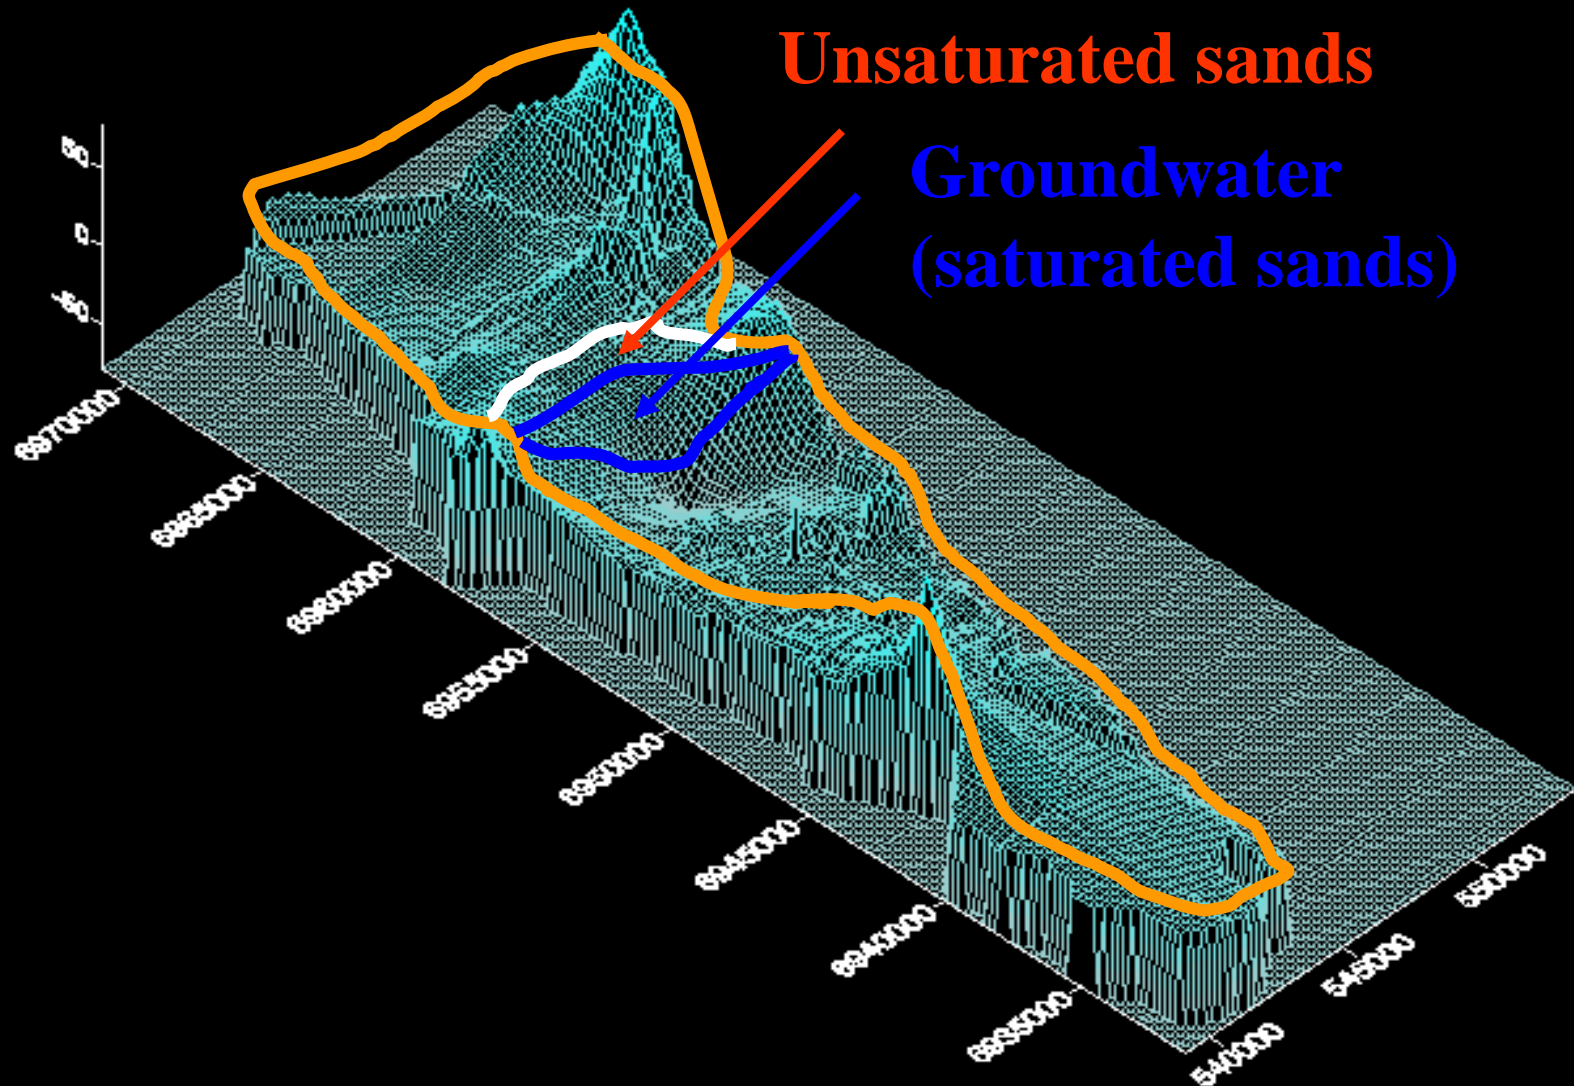
Saturated and unsaturated sands in one cross -section

(Diagrammatic perspective)

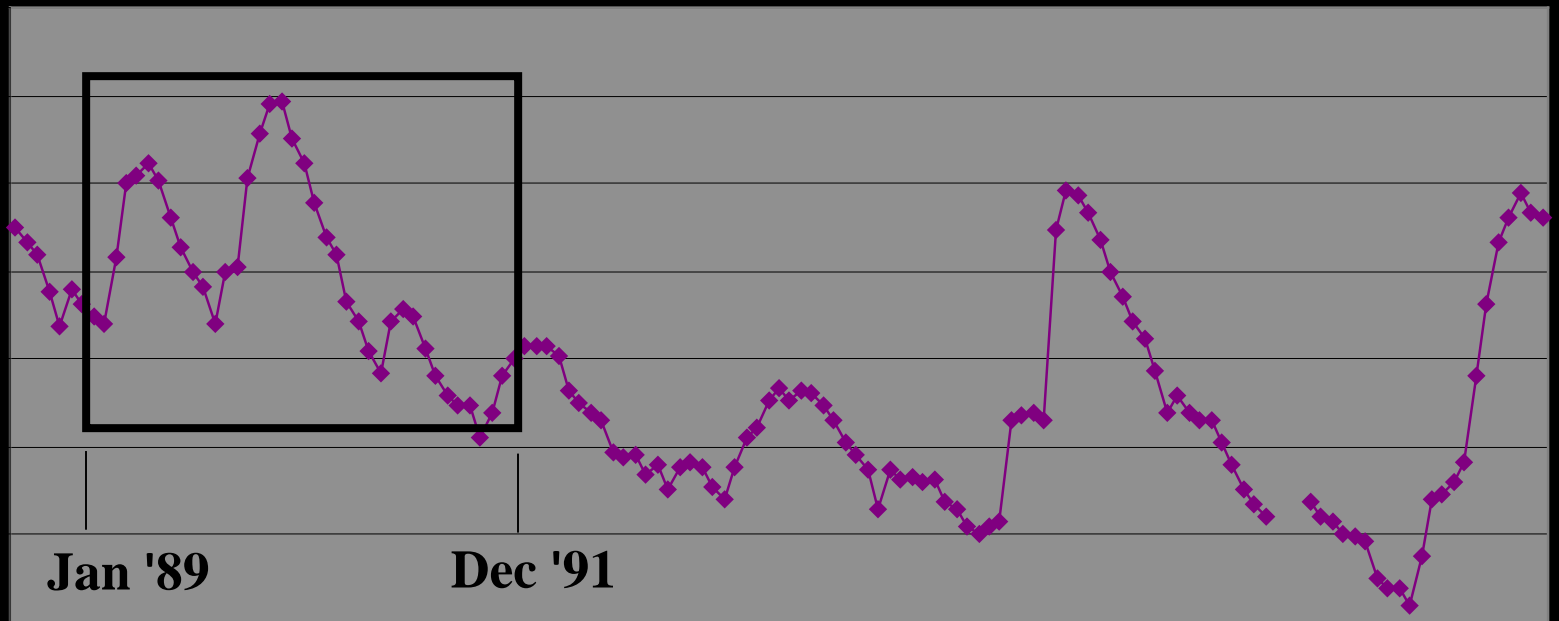
Monthly rainfall near Swallow Lagoon,
January 1989 to December 1991

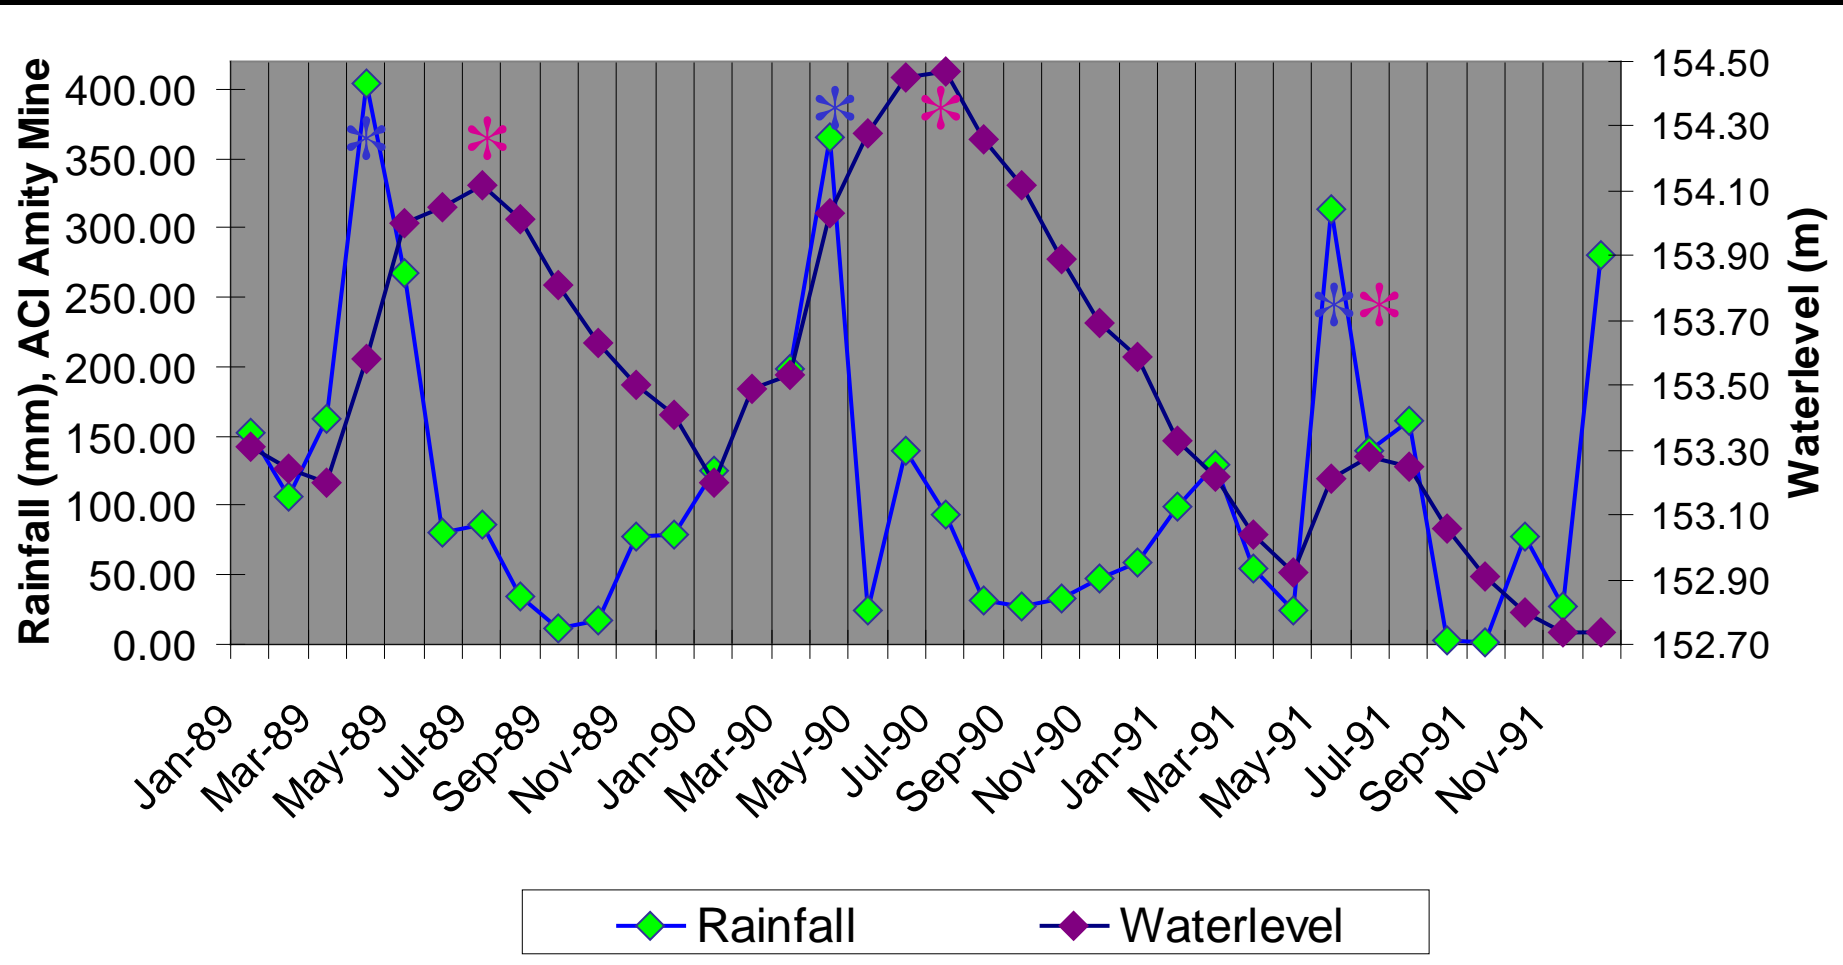
Waterlevel fluctuation in Swallow
Lagoon, July 1988 to January 2000

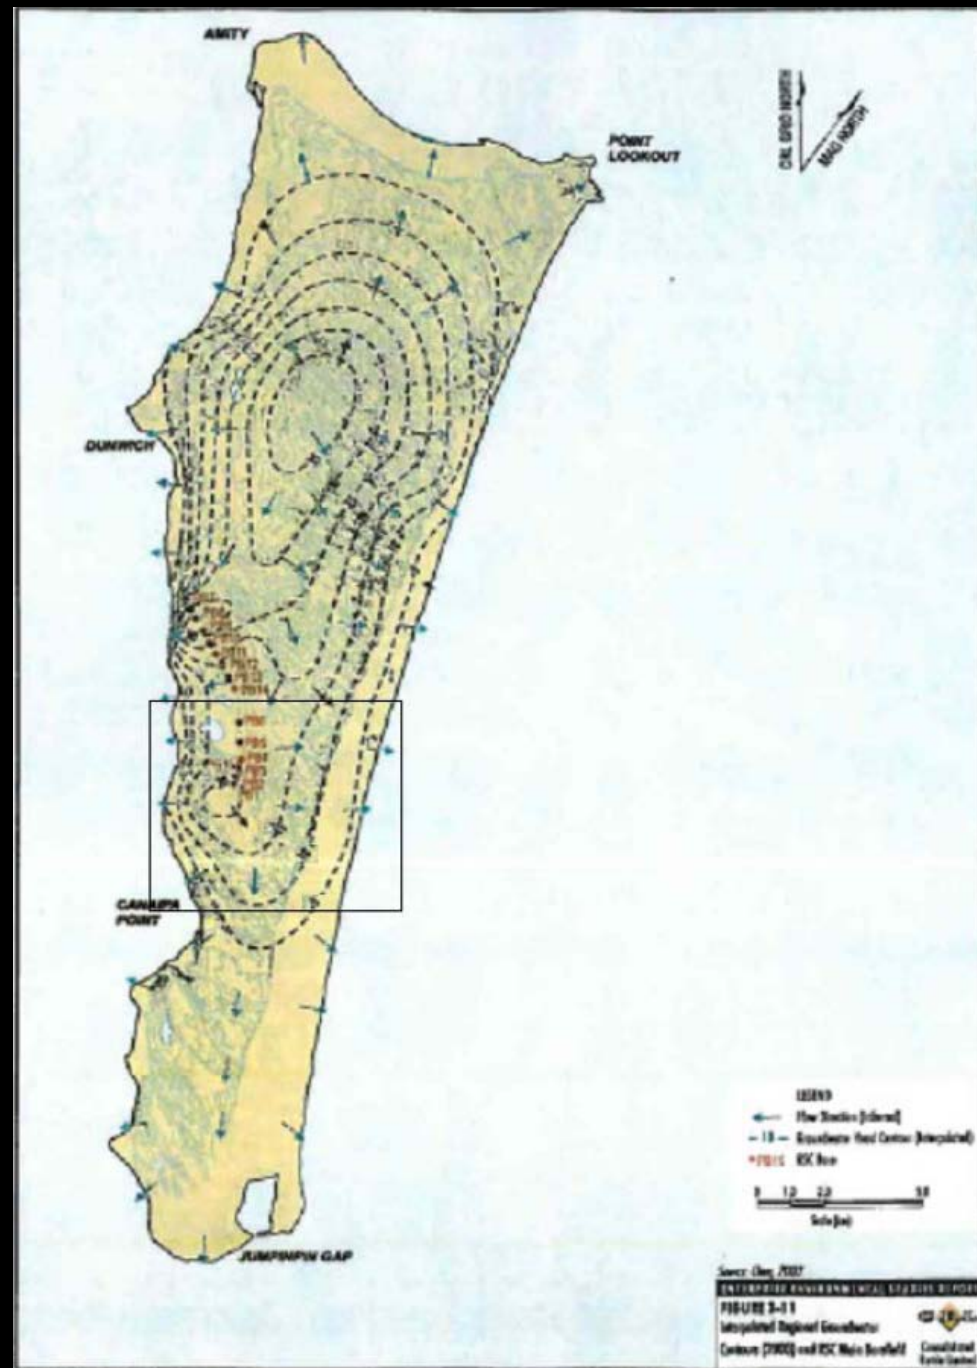
Natural
groundwater
variations affect
subsurface
movement of
water losses
from mining

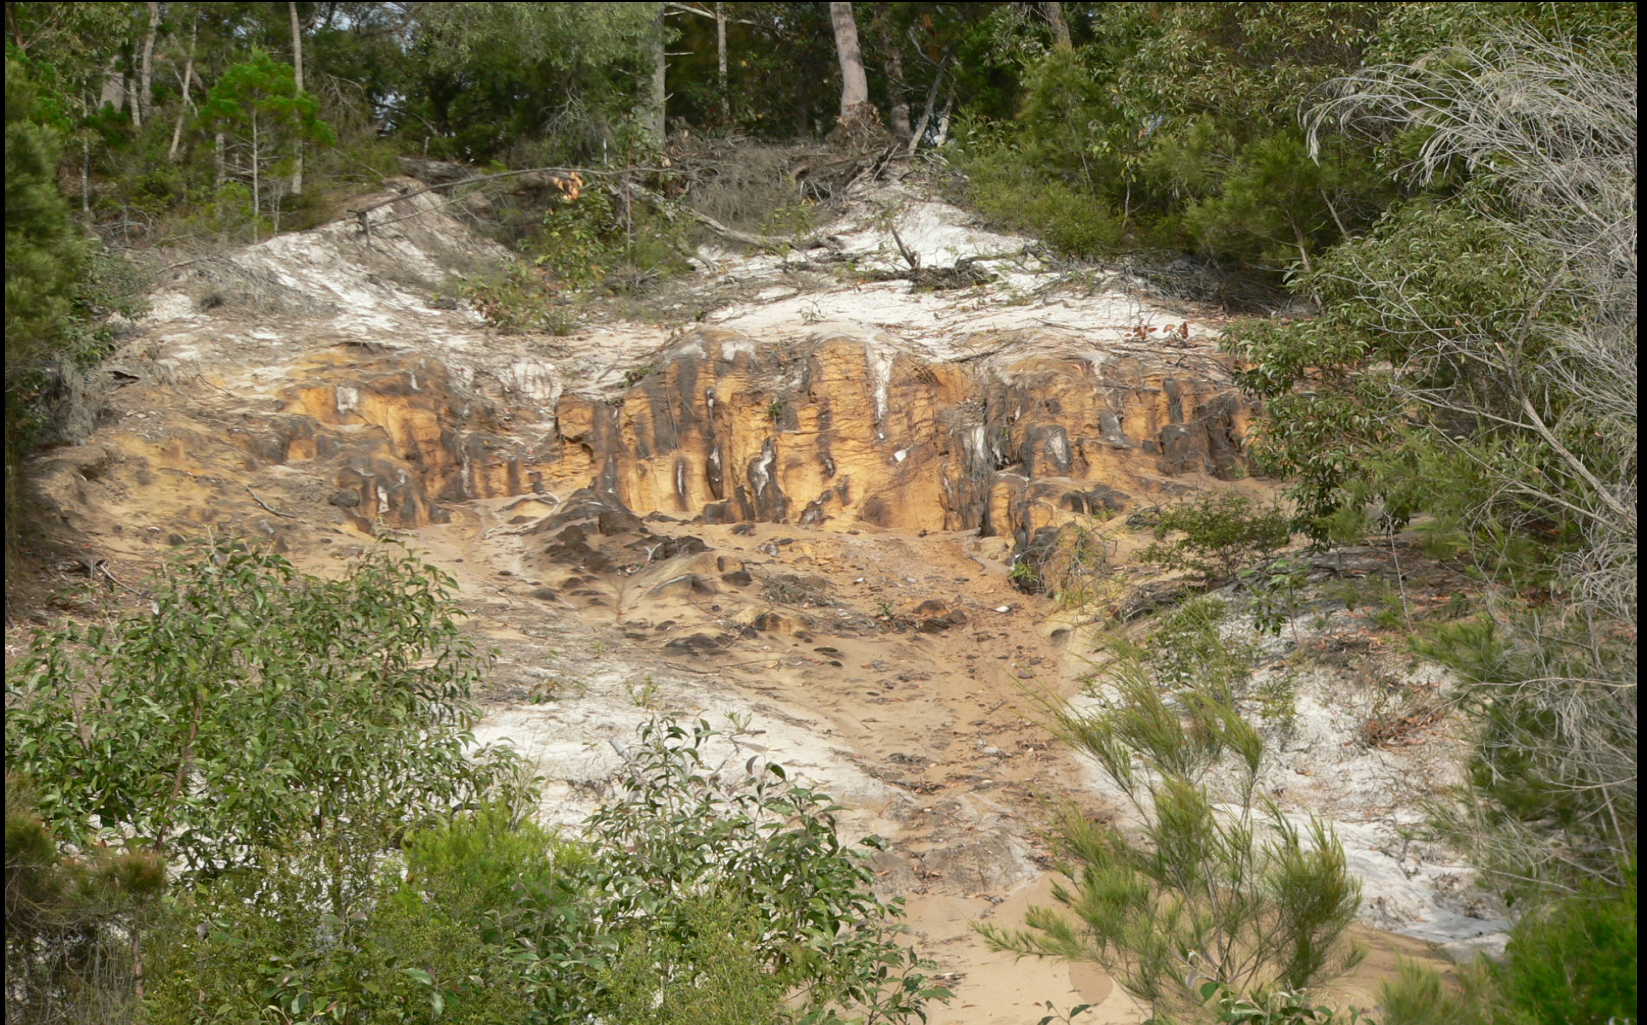
B-horizon of a soil...a type of semi-permeable
aquitard slowing groundwater movement

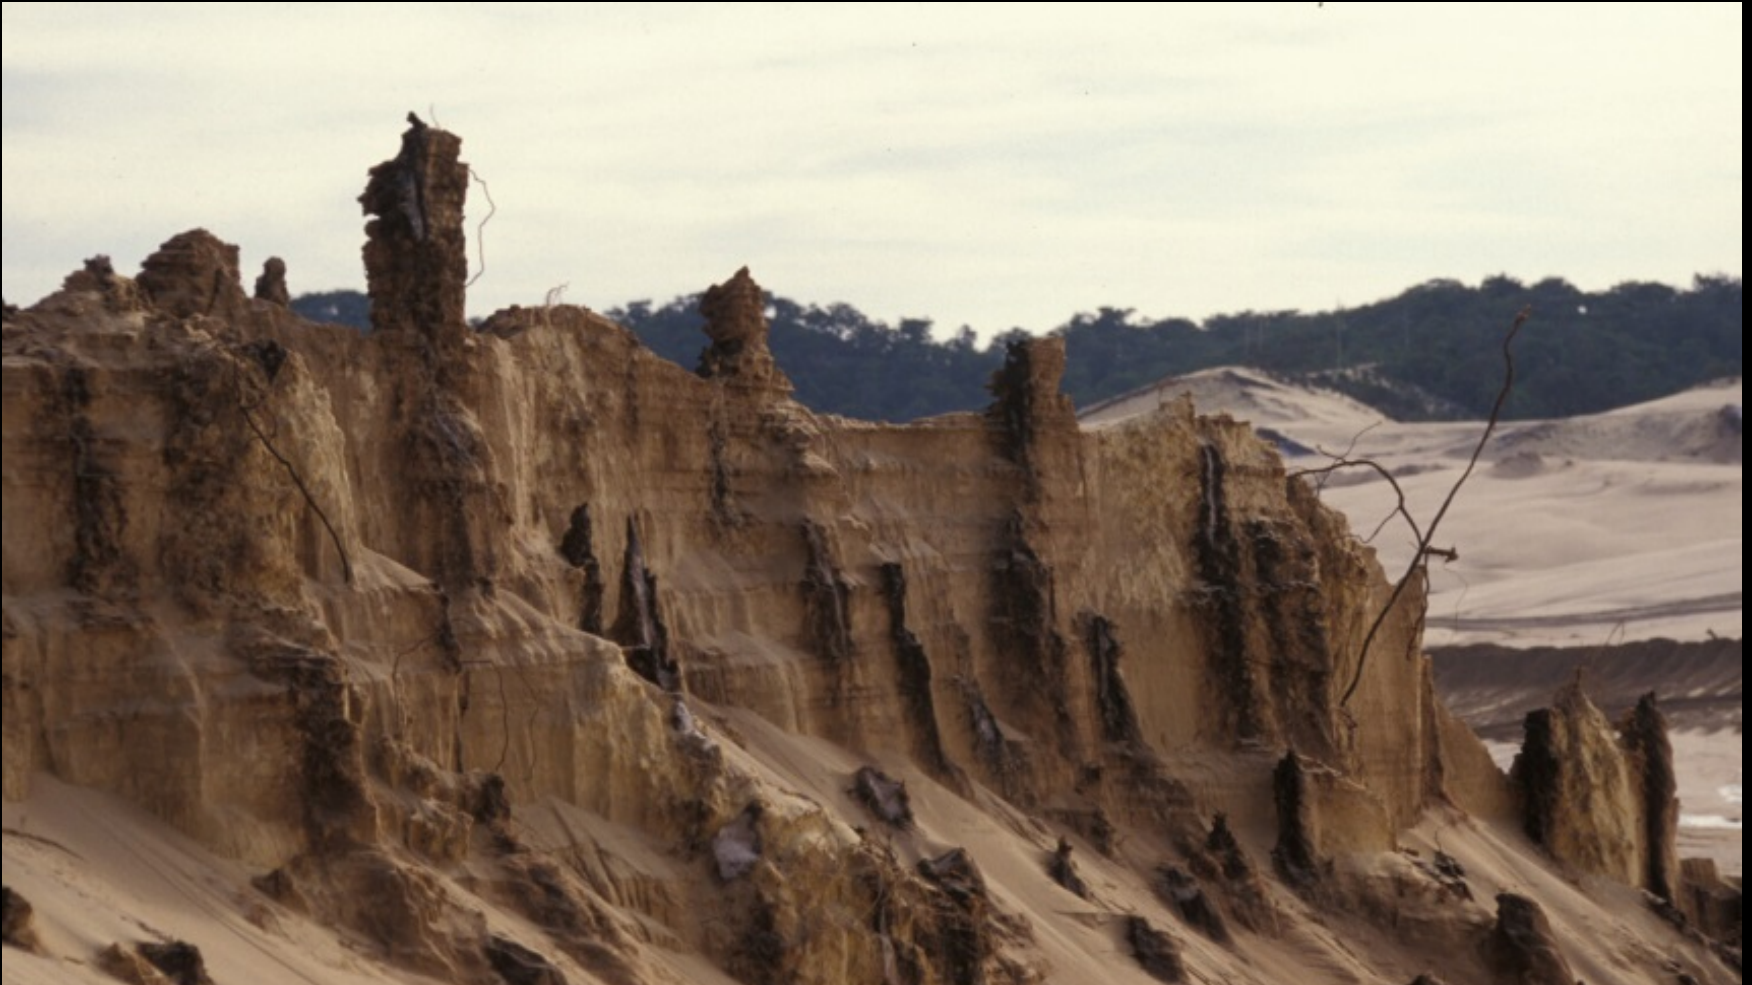
B-horizon in giant podsol exposed by mining

a type of semi-permeable aquitard slowing groundwater movement

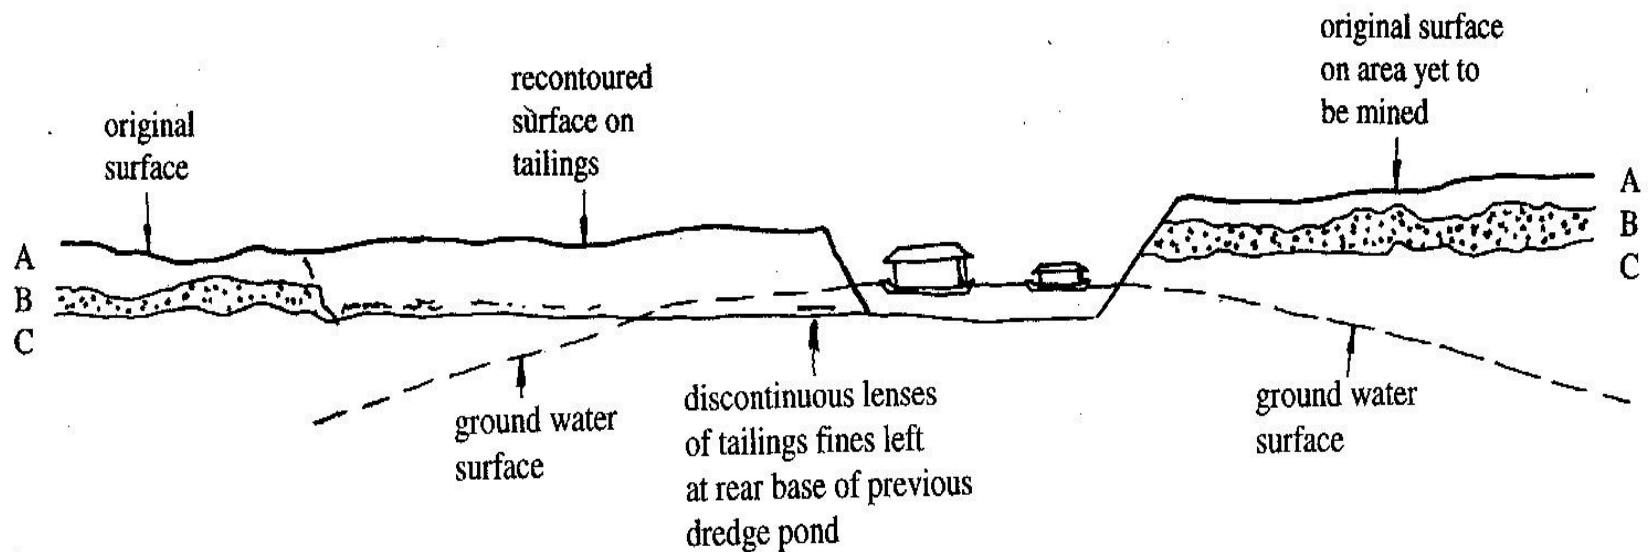
Long section of dredge tailings replacing natural soil profile

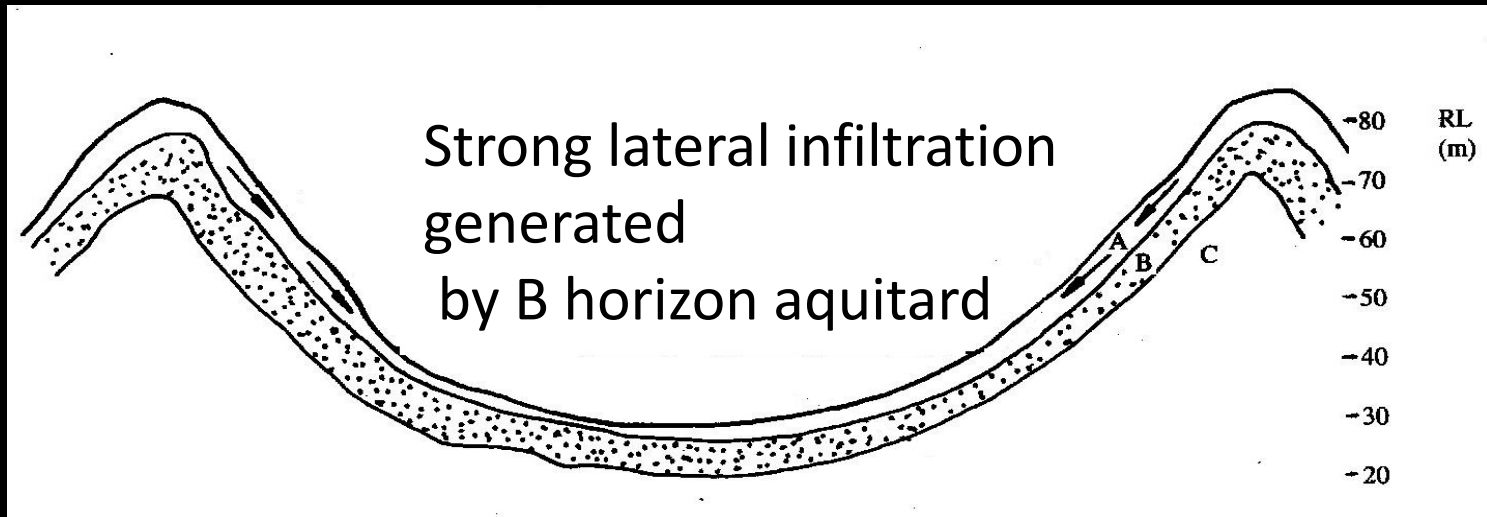
Cross section of natural soil profile

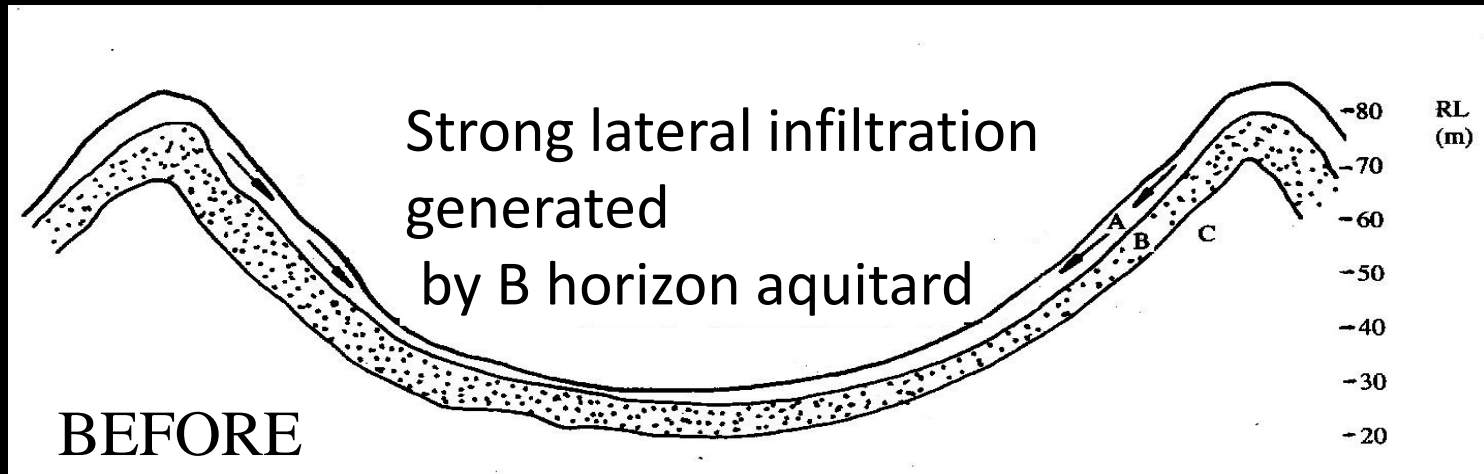
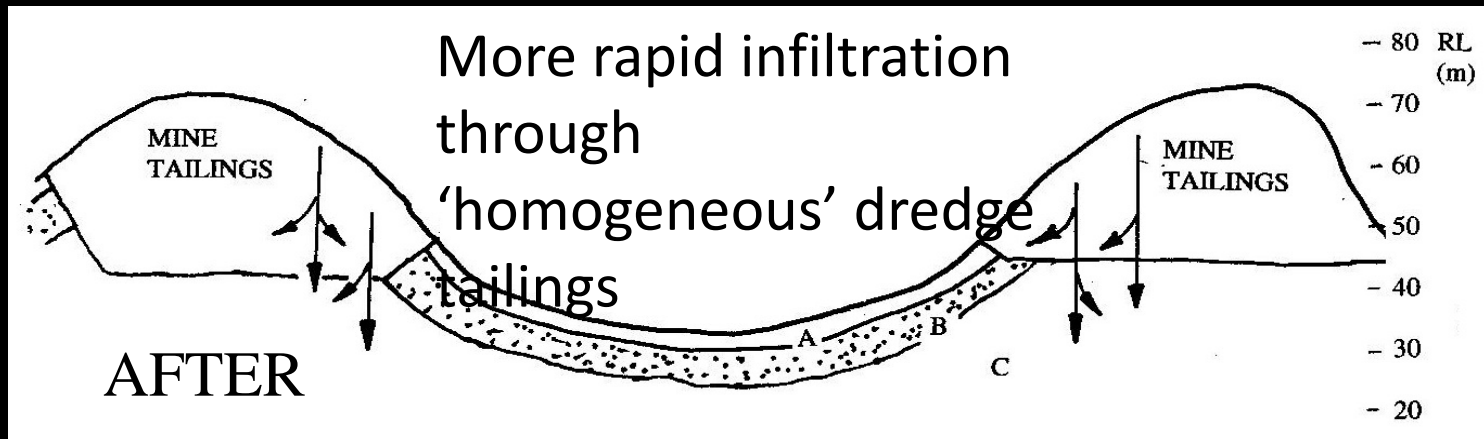
Cross section of natural soil profile replaced by dredge tailings

Mining legacy: original soil profiles replaced by wedges of mine tailings

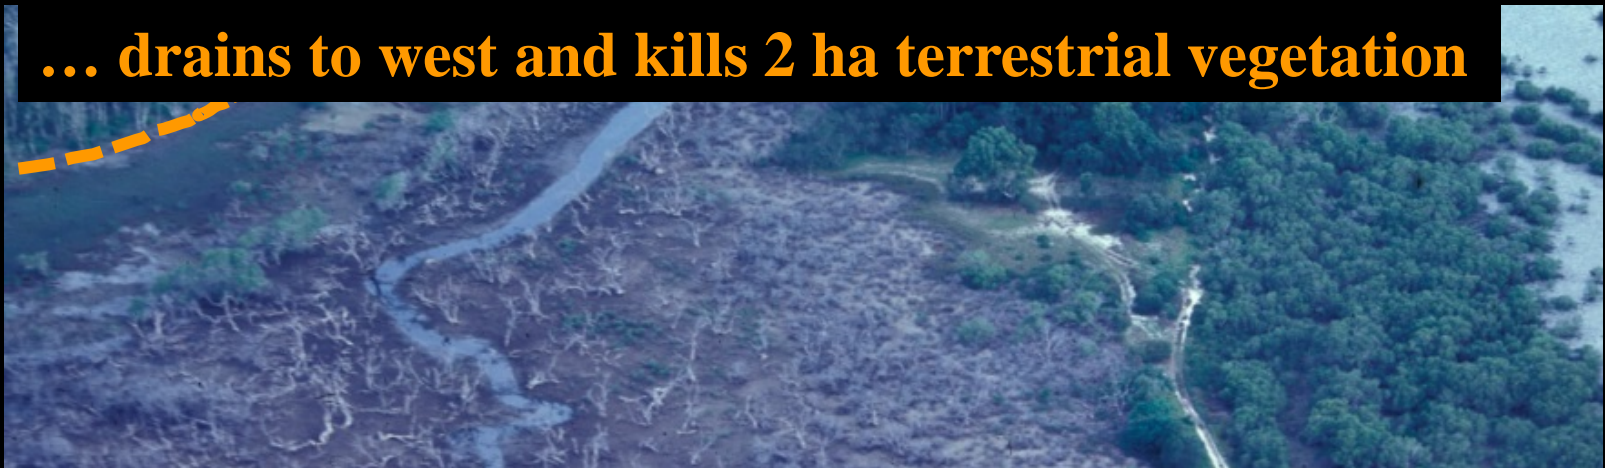
Salt water pumped from Wallum Creek to dredge pond ...

... drains to west and kills 2 ha terrestrial vegetation

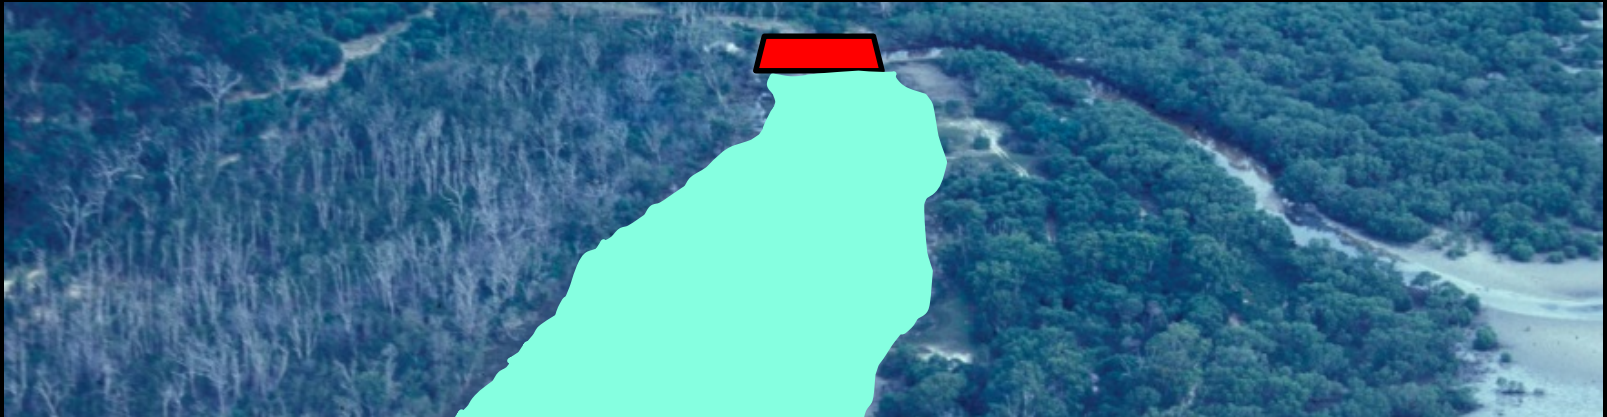
Bund dam built across Wallum Creek to exclude salt water

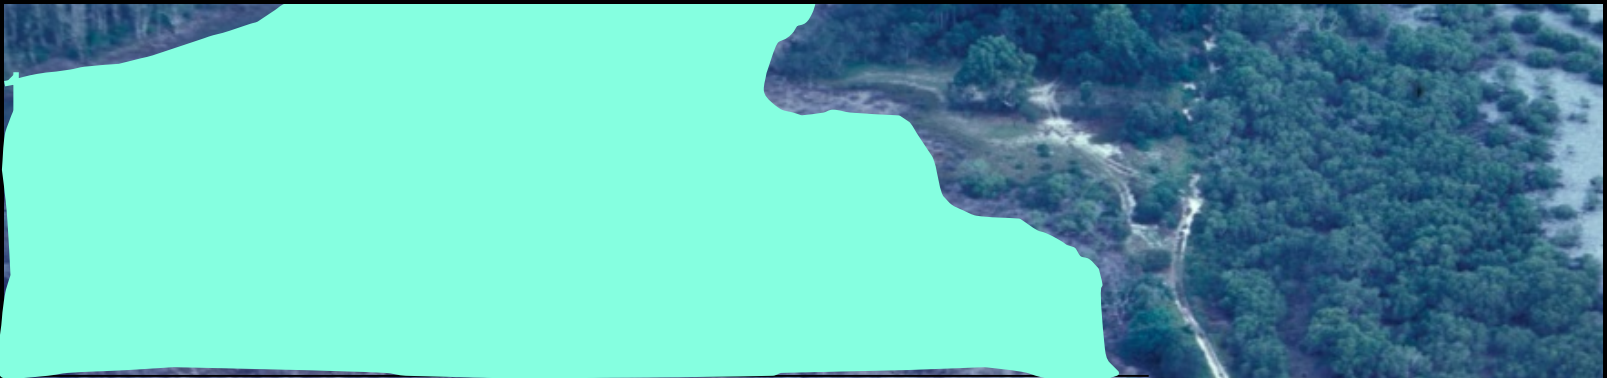
Impounded freshwater kills mangroves and intertidal fauna

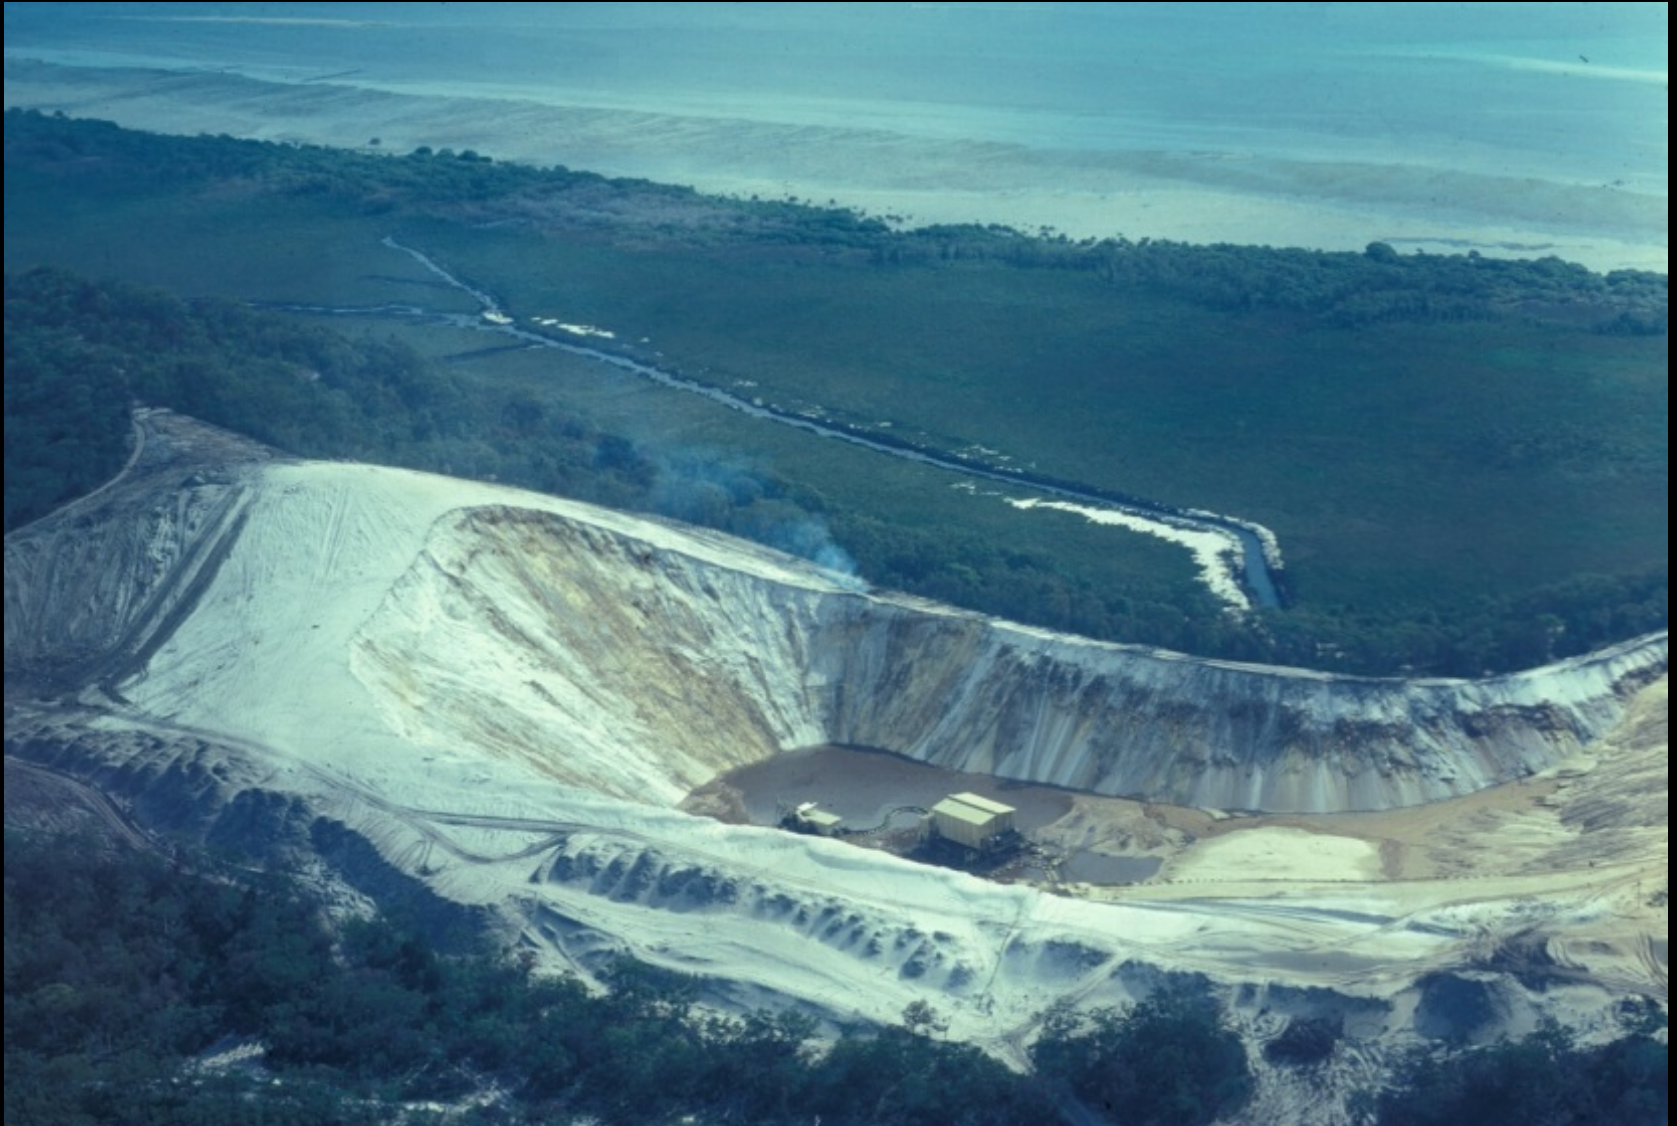
Channel cut in Amity swamp to supply make-up water to Amity Mine

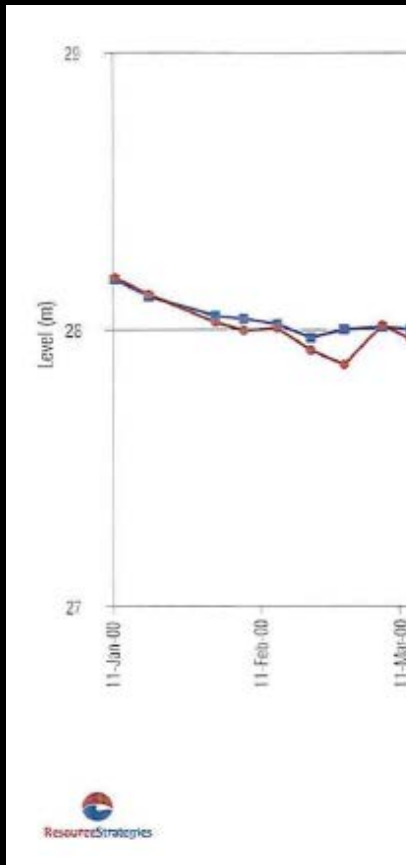
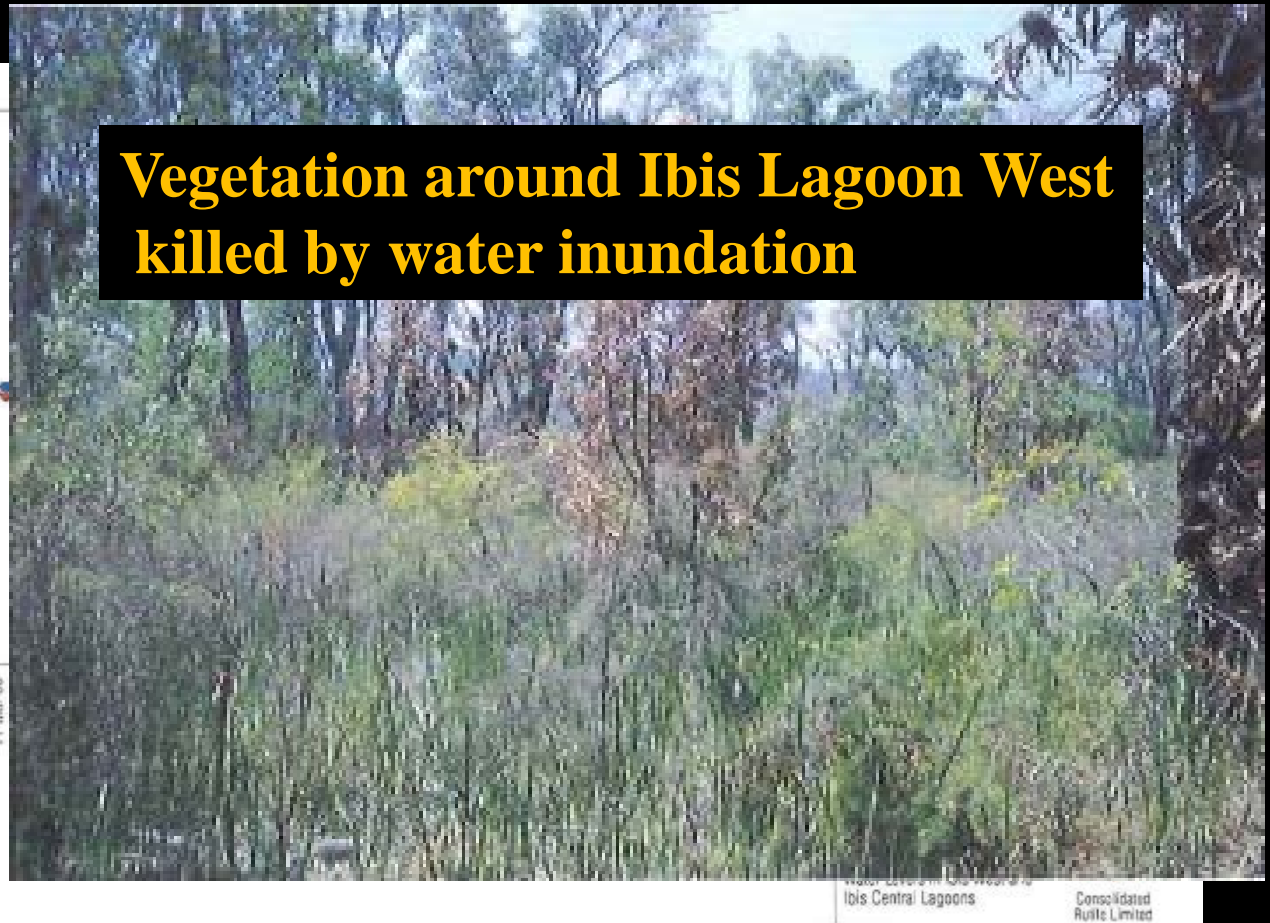
Surface water levels in two Ibis lagoons during part of 2000

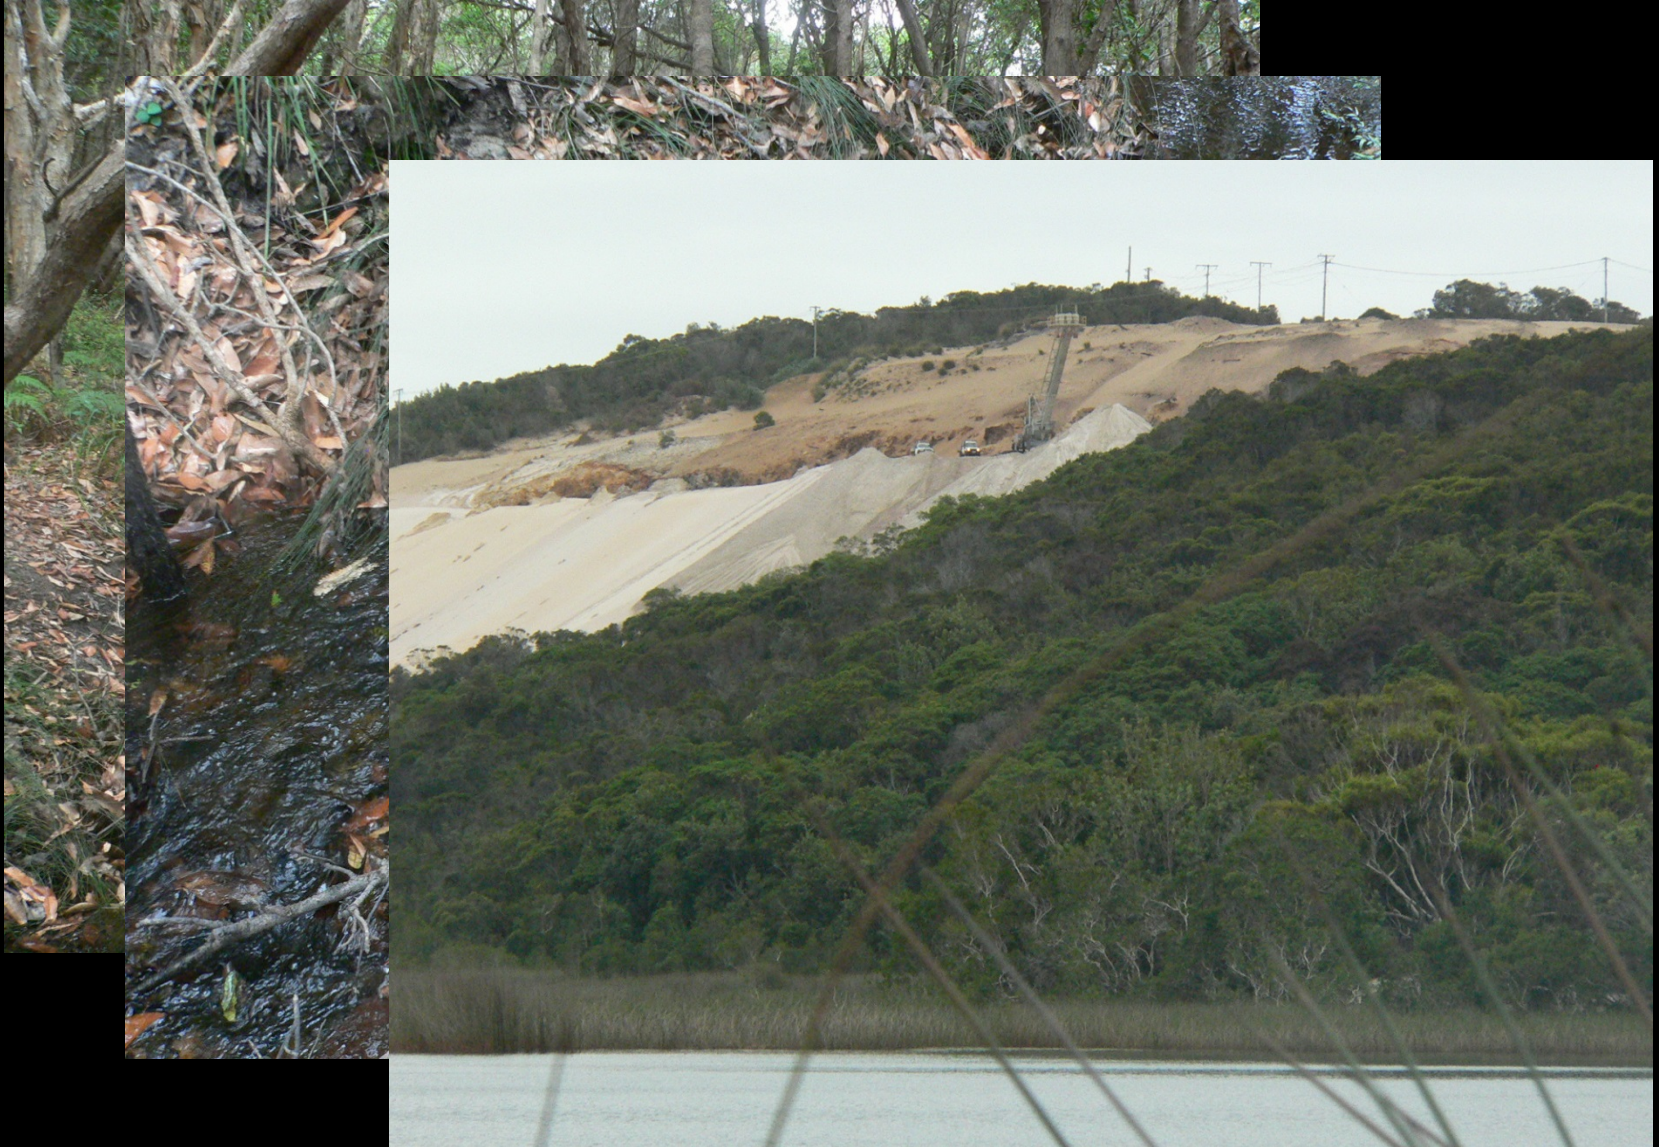
Water discharge from Yarraman Mine through poor management of tailings water

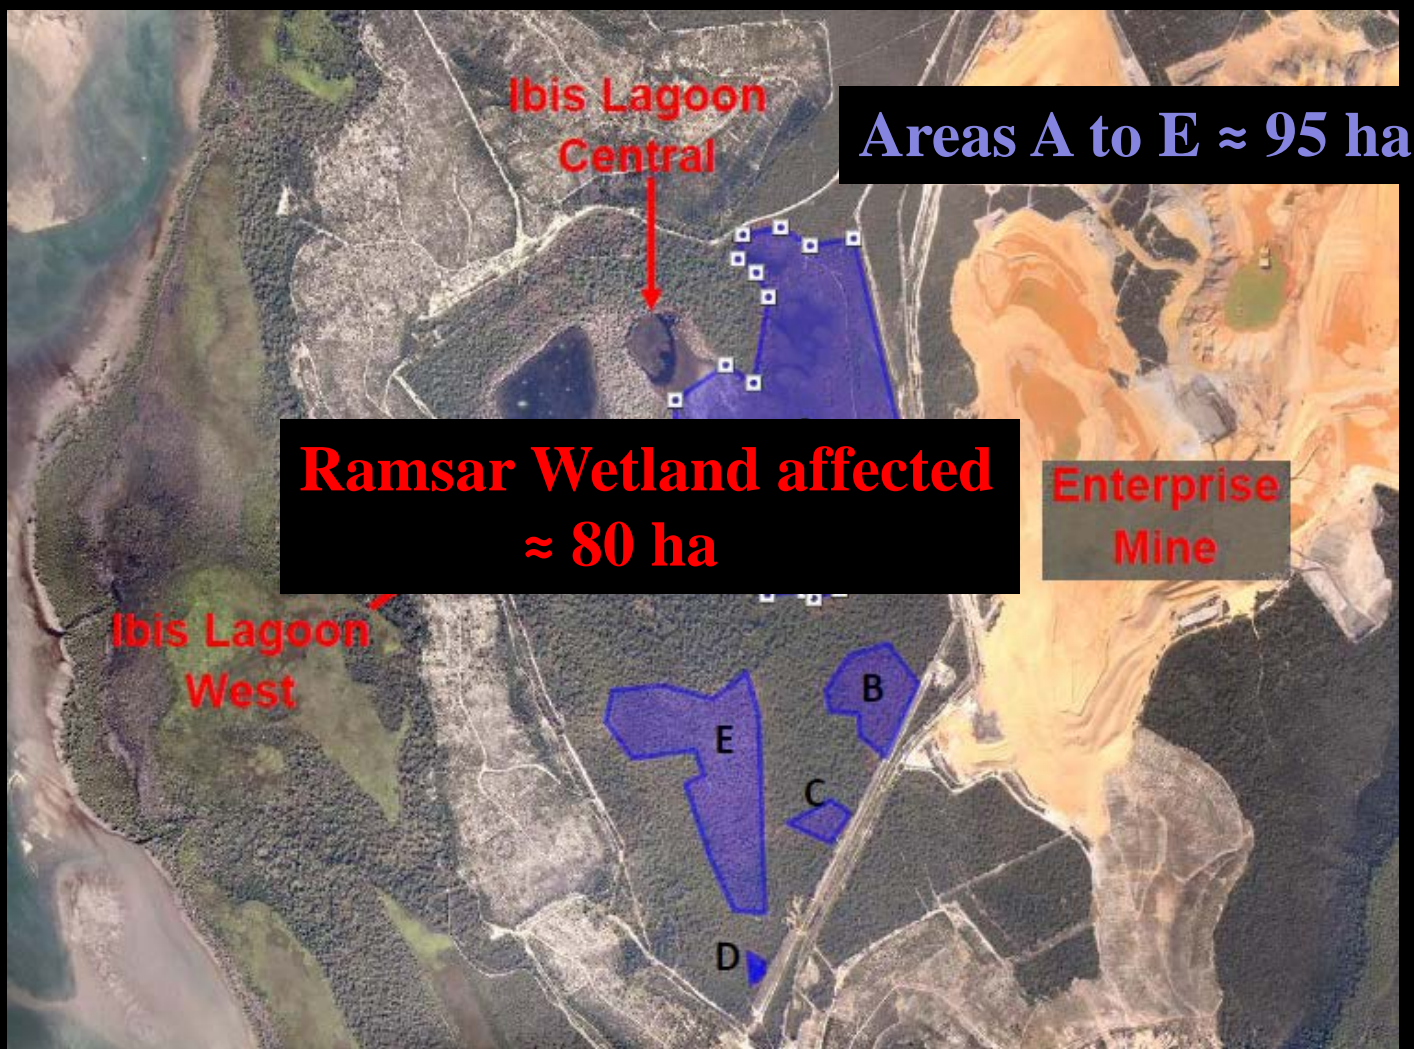
Compilation of flood-damaged areas, Ibis Lagoon system on 6 May 2010
