SAND DUNES, SOILS AND WATER – IMPACTS OF MINING ON NORTH STRADBROKE ISLAND

Presentation to FAC
Parliamentary Committee
10 March 2016

Prepared by Dr Errol Stock

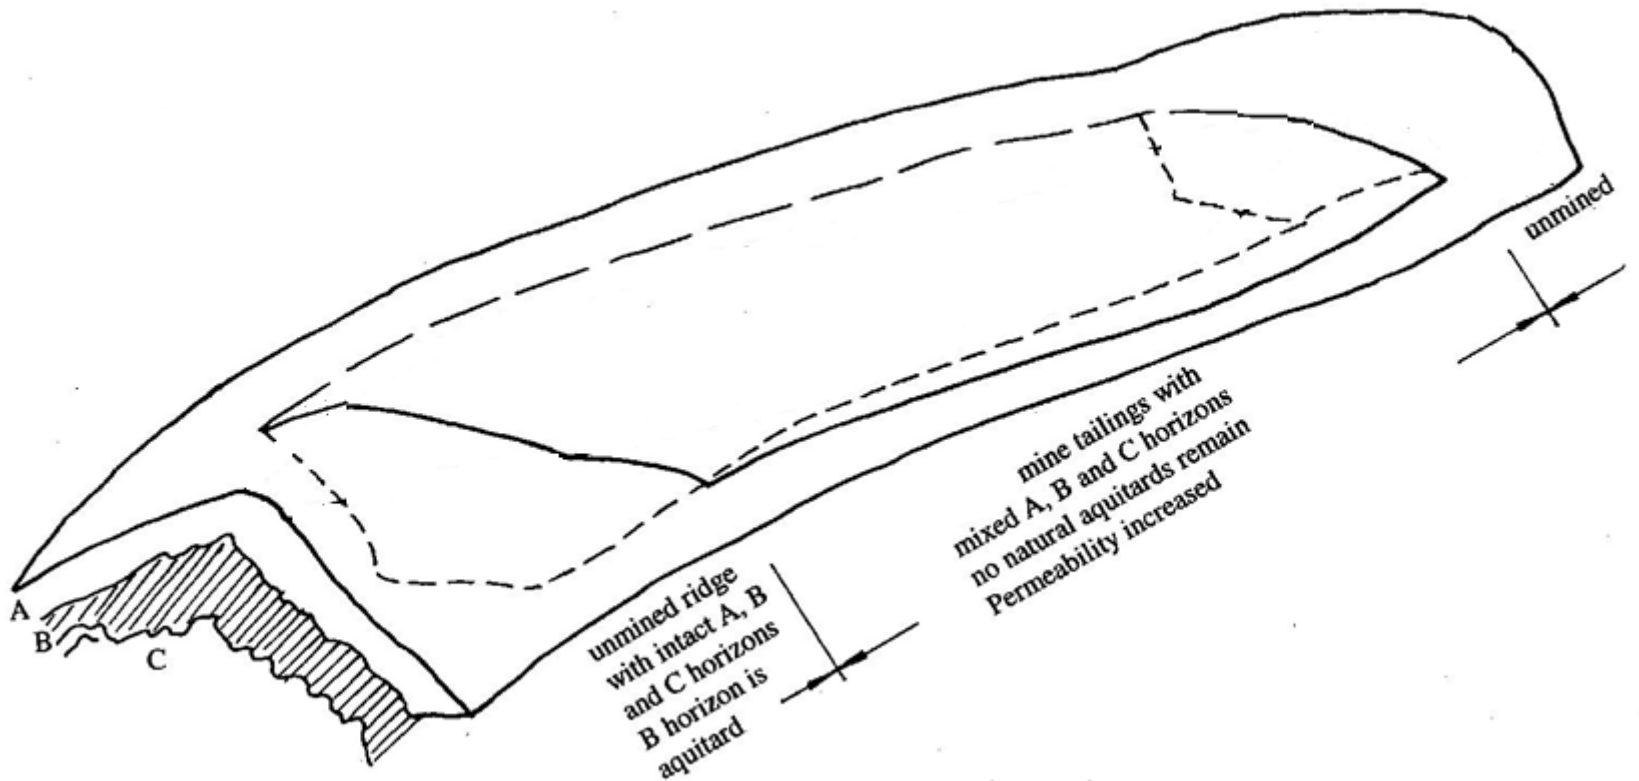
Mining legacy: original soil profiles replaced by wedges of mine tailings
